Worksite in Focus

Linn Run Road Somerset / Westmoreland County

7/2008

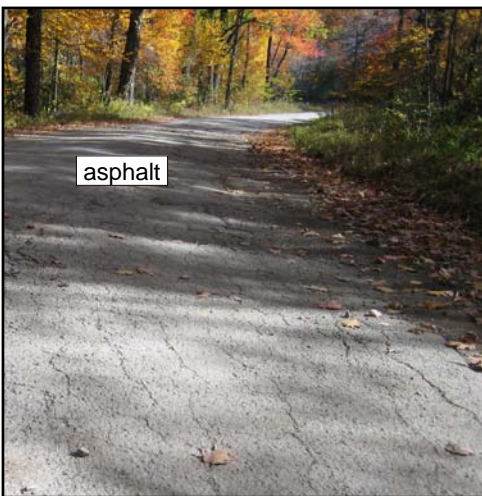
The existing "tar and chip" road is failing. This section of road will be converted to gravel.

The Bureau decided to reclaim the road using the Dirt and Gravel Road Program. Because of the relatively thin layer of broken asphalt, Linn Run Road was an ideal candidate for a Full Depth Reclamation. This process grinds up the asphalt and mixes it with the road base (and sometimes added material) to create an unpaved road. This is a highly effective method to recycle the existing road material to create a stable unpaved road.

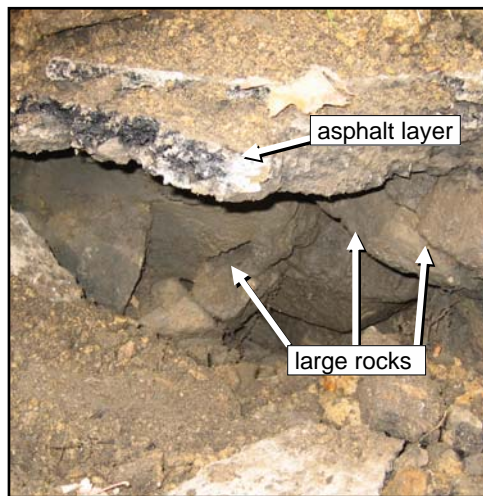
Before beginning a Full Depth Reclamation, it is ALWAYS advisable to take "road core" samples or otherwise examine the road sub-base. This will identify any potential problems, and determine if material will need to be added. In the case of Linn Run Road, the examination of the road sub-base exposed a potential catastrophe in the making. Just a few inches under the asphalt were large (2-3 foot diameter) sandstone boulders (see image below). These shallow boulders, most likely used to build the road on a saturated base, could have caused damage to the road reclaimer and left the road looking like the surface of Mars.

Investigation of road sub-base exposed large boulders preventing a full depth reclamation.

Because the existing road consisted of asphalt placed almost directly over large boulders, a full depth reclamation, described to the right, was not possible. In order to provide the cover needed over the roadbed of boulders, additional material would need to be imported. A bulldozer equipped with a “3-prong ripper” was used to break up the asphalt. In some cases, a simple carbide tipped grader blade can be used to break up the existing surface. The equipment needed depends on pavement thickness, pavement condition, and road base composition. A layer of 2A aggregate was mixed into the broken pavement to prevent it from “reconstituting” into an asphalt layer. Because of wet site conditions, a layer of separation fabric was placed over this new road sub-base. The fabric was covered by a ~6” base layer of 2A aggregate which was placed at optimum moisture, shaped, and compacted. Driving Surface Aggregate (DSA) was placed onto the 2A base using a paver at an uncompacted depth of 6”, and compacted to 4½”. This process resulted in a gravel road that is sufficiently elevated over the boulders buried under the road. The new road can now be easily maintained as an unpaved road by the Bureau of Forestry with existing equipment. In some cases, an unpaved road surface can be made by simply mixing small amounts of aggregate or stabilizer with the broken road (no DSA). A process called a “mini-stabilization”. This was not an option on Linn Run Road because of the shallow boulders. More information is available about DSA at www.dirtandgravelroads.org under Resources: Driving Surface Aggregate.

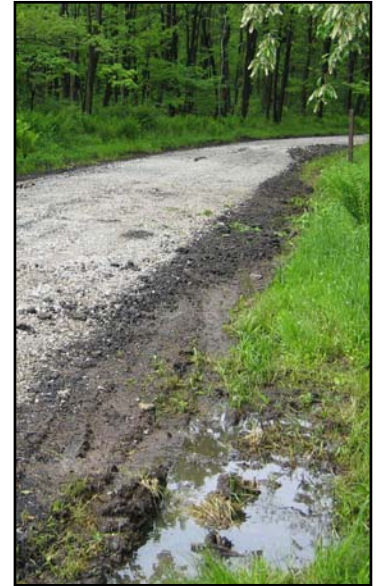
While the main focus of the Linn Run Road project was on a road surface rehabilitation, a significant amount of work was done to address drainage concerns around the road. The photo to the right illustrates the existing condition on much of the project site. Consistently wet ditches meant that driving off the road surface could get you stuck. The large quantities of water in this relatively flat area also made ideal conditions for rutting, potholes, and other deformations resulting from a saturated road base. While road surface improvements are the most visible component of this project, the drainage improvements will help to insure that the new road surface will last as long as possible.

It may seem strange to have water table issues near the top of a mountain at an elevation of over 2,700 feet. Excavations done to install crosspipes revealed the answer. Approximately 6 inches below the surface of the ground was a thick layer of dense clay. This impermeable clay layer served as an aquatard, preventing drainage and keeping the surface saturated. This aquatard is most likely why large sandstone boulders were used to build up the sub-base of the road.

Much of the existing road was saturated for extended periods of time due to an impermeable clay layer.

While several new crosspipes were added to Linn Run Road, most of the drainage work concentrated on underdrain. Because much of the road was saturated as pictured above, over 4,000 feet of constructed underdrain was used on the site, largely under the parallel ditch line. The underdrain collects sub-surface and standing surface water and transports it to a stable outlet. When possible, clean underdrain water is outletted separate from ditch drainage. In most cases, the underdrain is buried 6-12 inches below the surface. On Linn Run Road, this was not possible because the clay-heavy soil actually sealed the underdrain and prevented it from draining standing surface water. For this reason, the underdrain was covered with free-draining stone that was left exposed in the ditch in several locations. For more information, two technical bulletins are available on underdrains at www.dirtandgravelroads.org under Resources: Technical Bulletins.
