# Worksite in Focus

## Tioga County Fall Brook Road

4/13/05

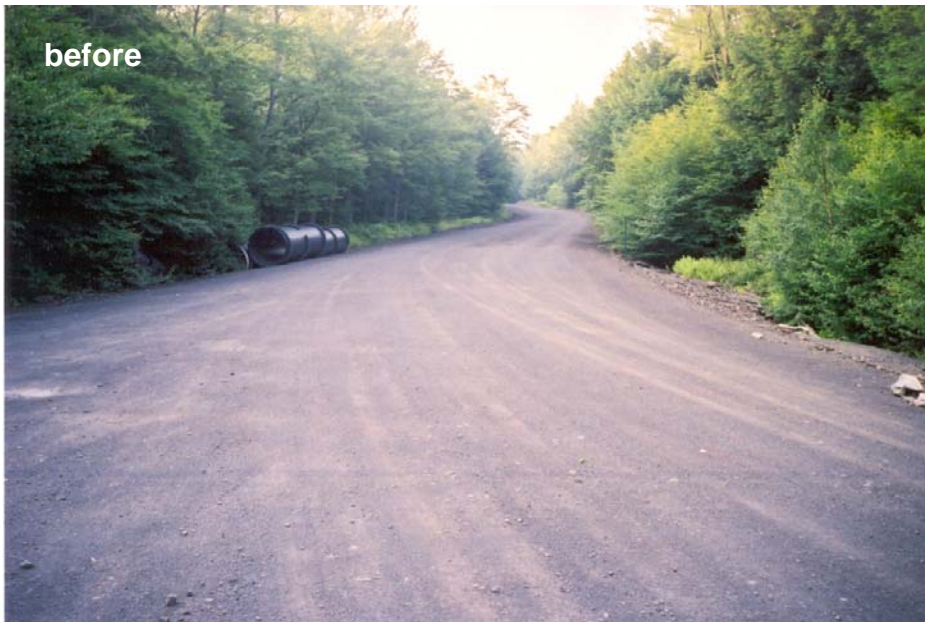
Before: Fall Brook Road was so wide, the township could not keep the road crowned. The road surface of coalmine spoil held water and was full of potholes during wet periods and was a constant source of dust in the summer. High flows sent water flooding across the road eroding the surface material directly into Fall Brook. Although already impacted by acid mine drainage, Fall Brook did not need an additional source of impairment.
