# Worksite in Focus

## Carbon County Spruce Road

### Project Overview:

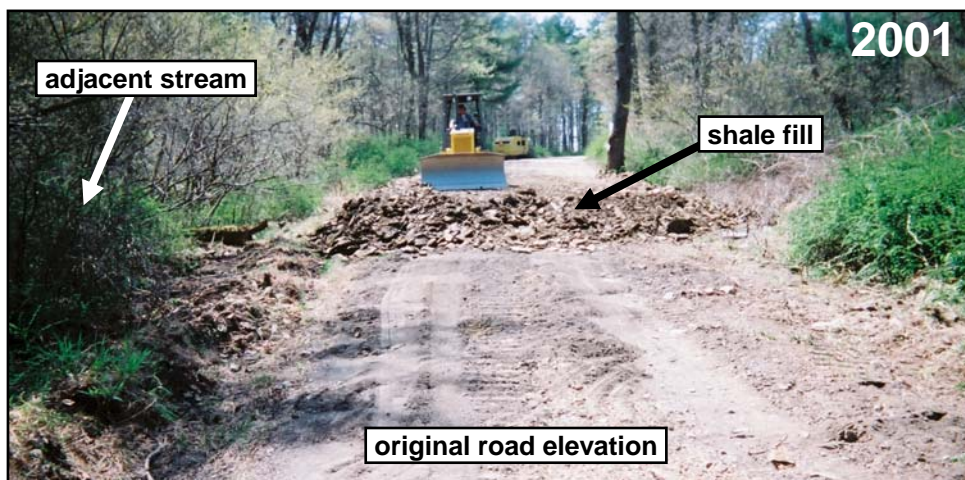
Shale was used to fill the road up to 24" in places to provide a better road base and keep the stream out of the road. This practice was highly successful and was key to the road improvement project. The added fill also provided the much needed cover for installing additional crosspipes.

Photo 1. Spruce road was filled with up to 2' of shale in places to provide a better road base and elevate the road above the adjacent stream.

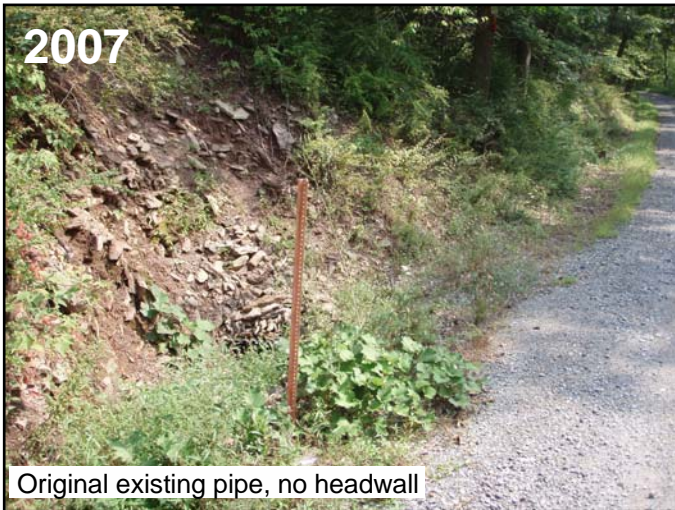
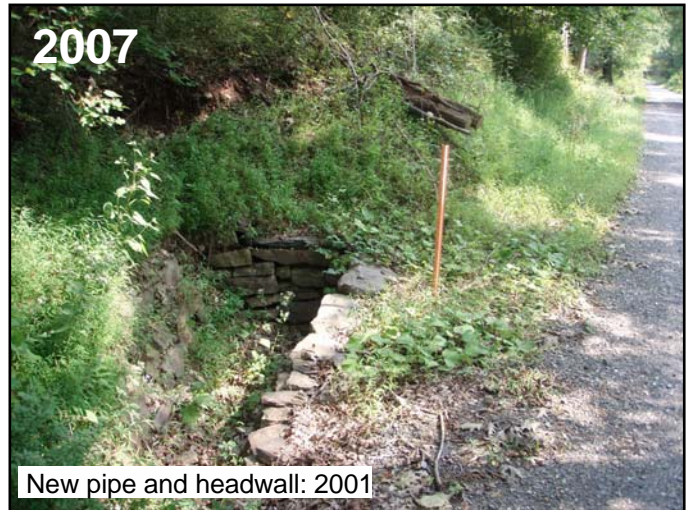
Before the project, only 3 crosspipes existed over the nearly mile long section of Spruce Road. These existing pipes were left alone (without headwalls) and create a useful contrast when compared to newly placed pipes. Seven new crosspipes were added in 2001 to reduce ditch erosion and disconnect road drainage as much as possible. Stone headwalls were placed around each of the newly placed crosspipes. The unprotected inlets of the three existing pipes serve as a constant source of sediment and could even clog pipes if a small slide were to occur. The new pipes and headwalls have been functioning well since placement in 2001. Photos 2 & 3 on the back compare two pipes, one existing without inlet protection, and one installed in 2001 with a stone headwall.

Photo 2 & 3. Six years after construction, the new pipe and headwall on the right is still stable. The existing pipe on the left was left alone. The unstable bank around the pipe inlet is a constant source of sediment and could clog the pipe if part of the bank were to collapse.

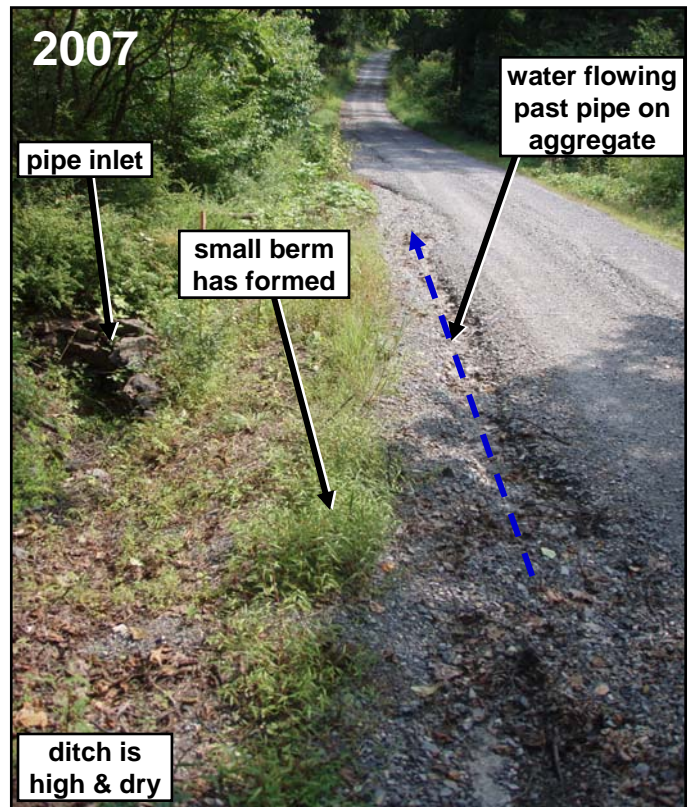
DSA was placed on Spruce road using a motor-paver in 2003. The road surface has not been graded or maintained in any way since it was placed. The driving surface itself is in excellent shape, however, it is beginning to suffer from lack of maintenance. Photo 4 illustrates a location where a small berm has formed preventing water from flowing into the ditch. Surface drainage that bypasses the crosspipe is eroding a channel into the DSA. Any aggregate, regardless of quality, will begin to erode under concentrated water flow. This problem can be avoided by grading the aggregate to remove the berm and allow drainage to enter the ditch and crosspipe. Several of the turnouts on this site are disconnected and no longer functioning for similar reasons.

Photo 4. The importance of maintenance. A simple grading would have reestablished the ditch, got water into the culvert, and saved a lot of surface aggregate erosion.
