7 Additional Program Policies

• 7.1 Stream Crossing Replacement Policy

Stream Crossing Project Examples "The Good, The Bad, and The In-Between" **Project Site Visits from 2018-2020 QAQC's**

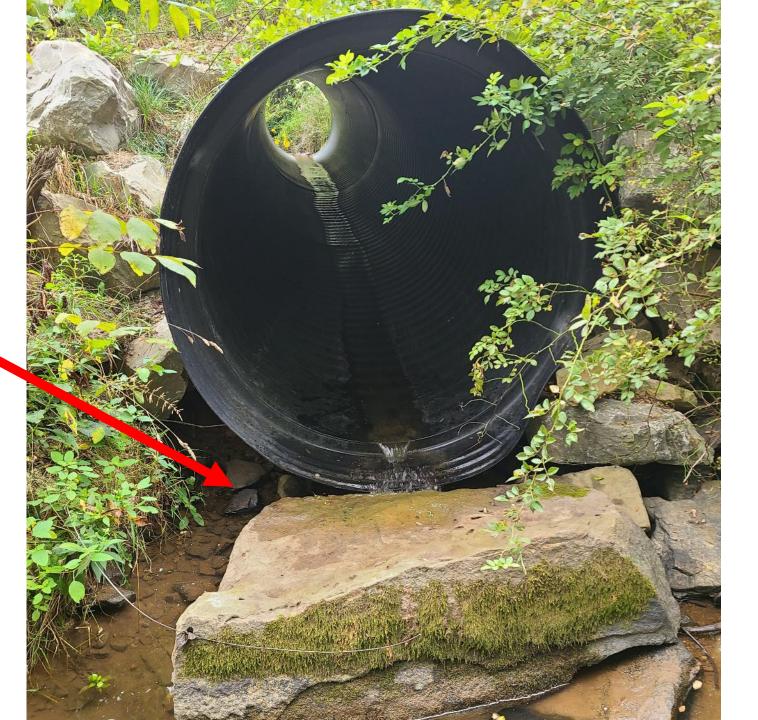
4' Round Pipe in 8' Bankfull

No streambed material in structure

Significant drop at outfall of structure

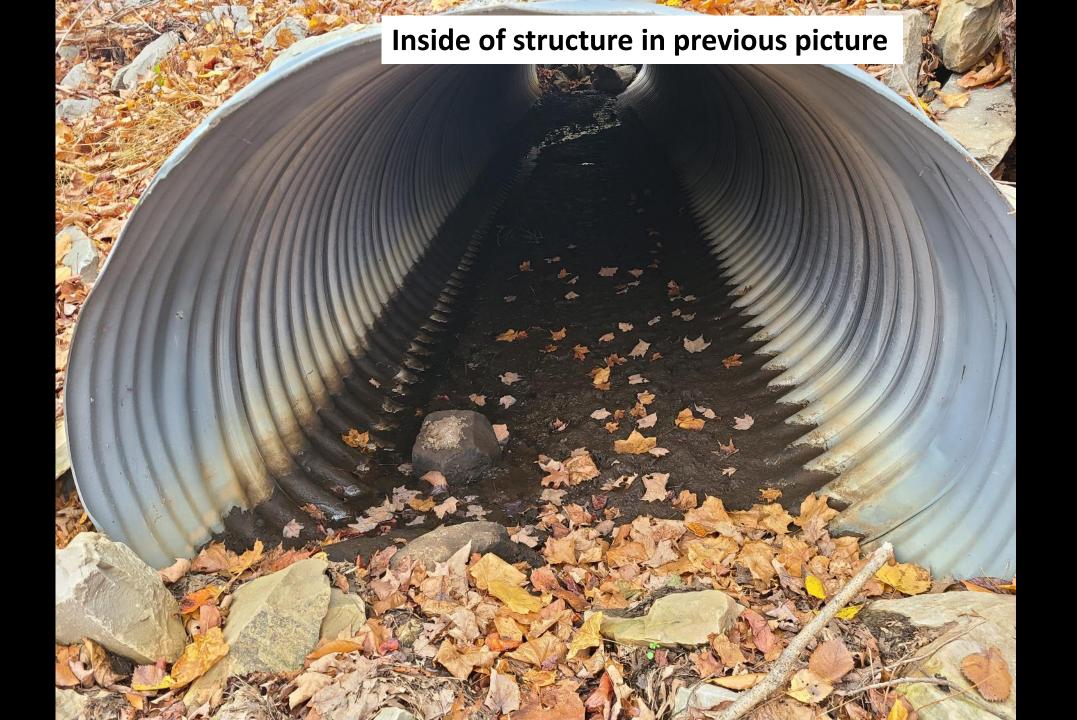
6' Pipe in 11' Bankfull. No AOP

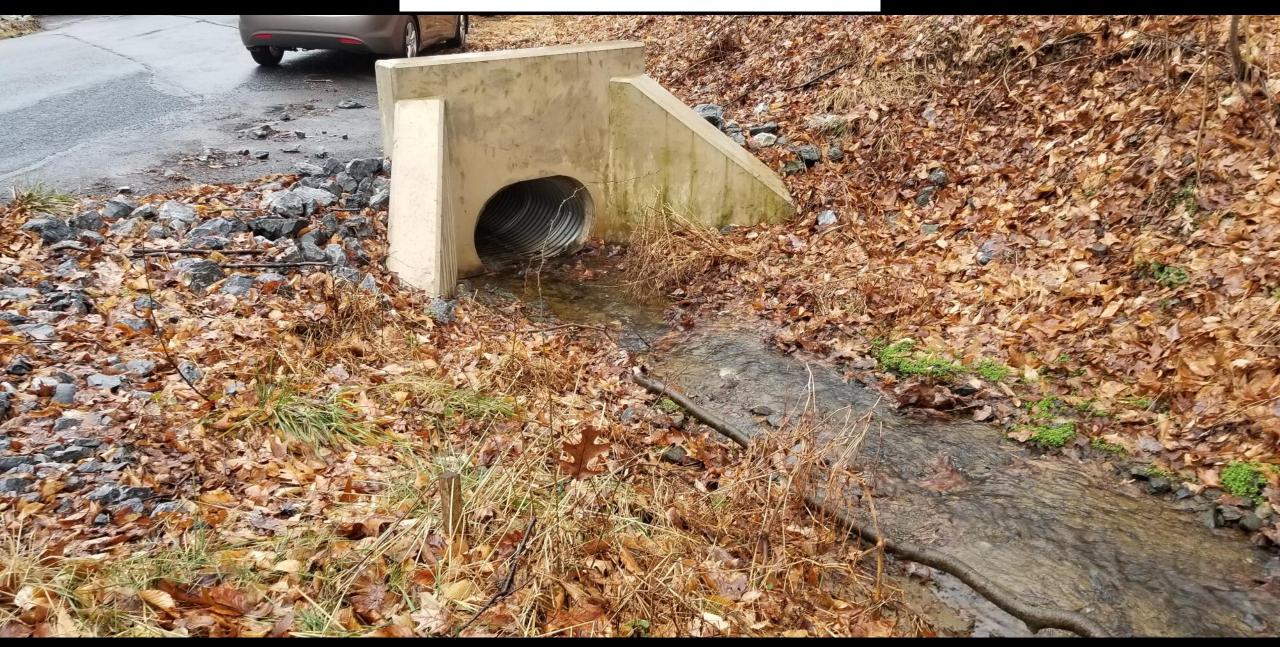
4' pipe in a 7' bankfull, No AOP

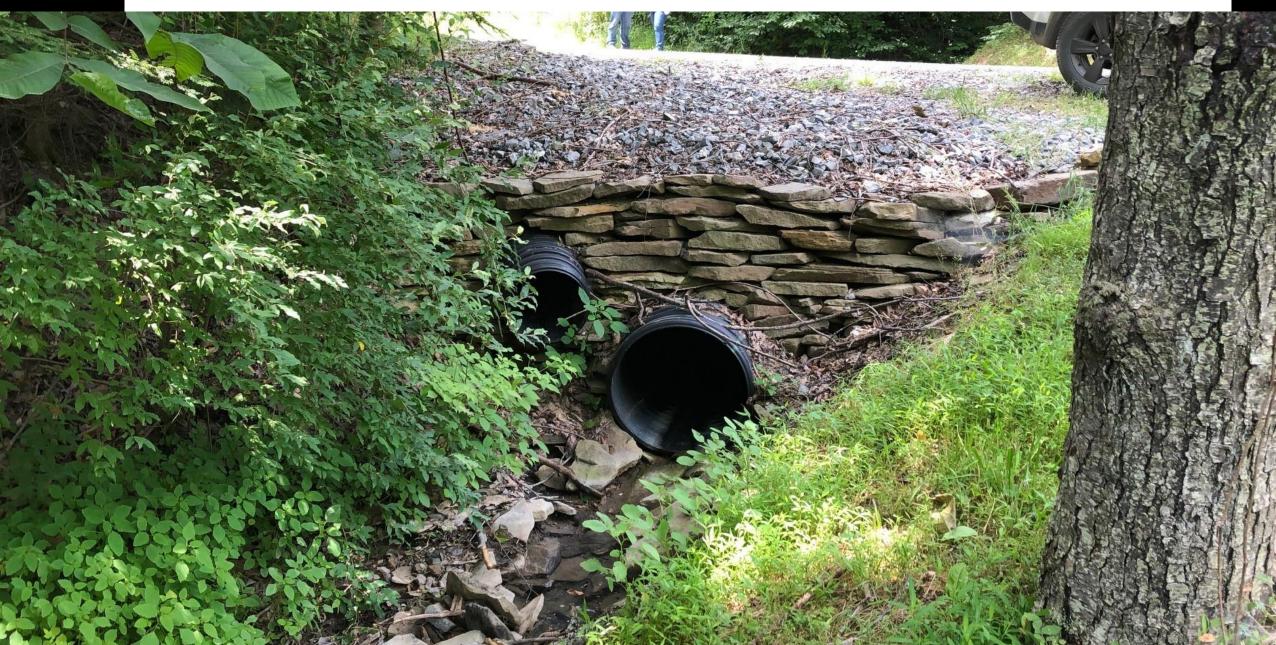
Structure is under bankfull and lacks AOP

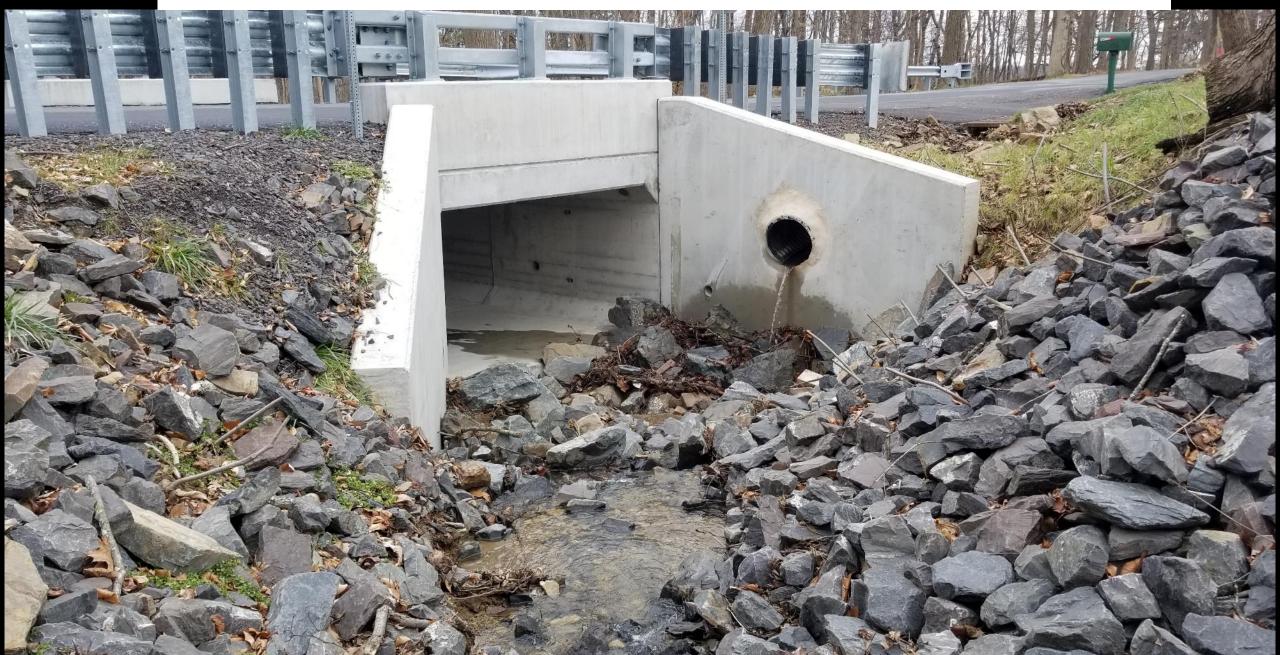
This structure is bankfull width, but lacks AOP

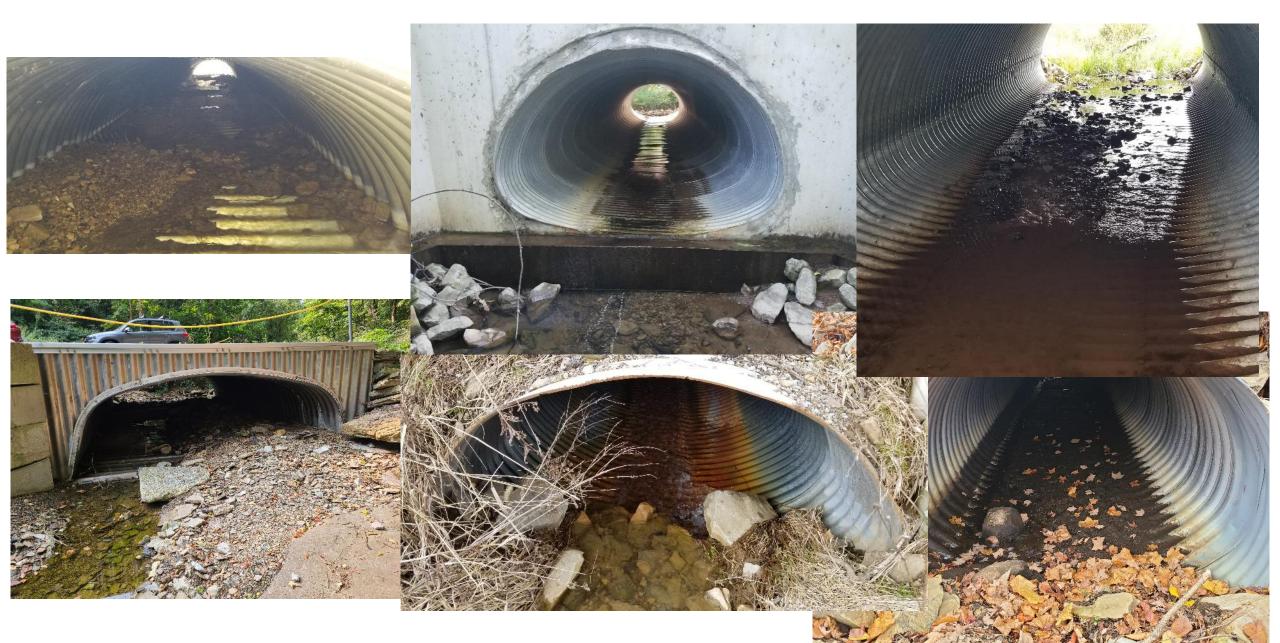
This structure is bankfull width, but lacks AOP

Shows typical issues with low profile arch

Bankfull width structure, No AOP

Structure will rust much faster without streambed material

Streambed material is <u>NOT</u> just for AOP

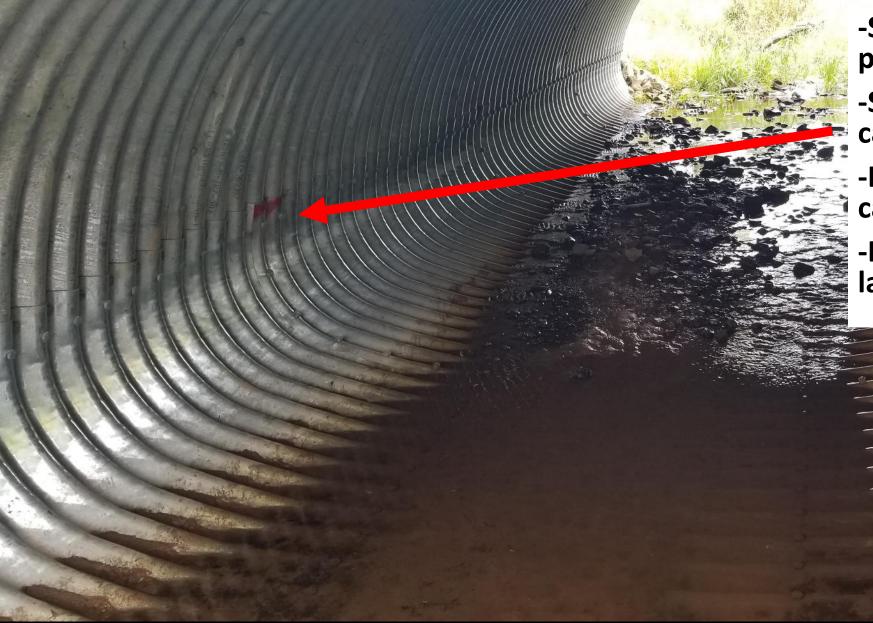
-Structure not depressed properly into stream bed. -Structure width is too high, causing stream to narrow

-Lack of streambed material causes "velocity barrier"

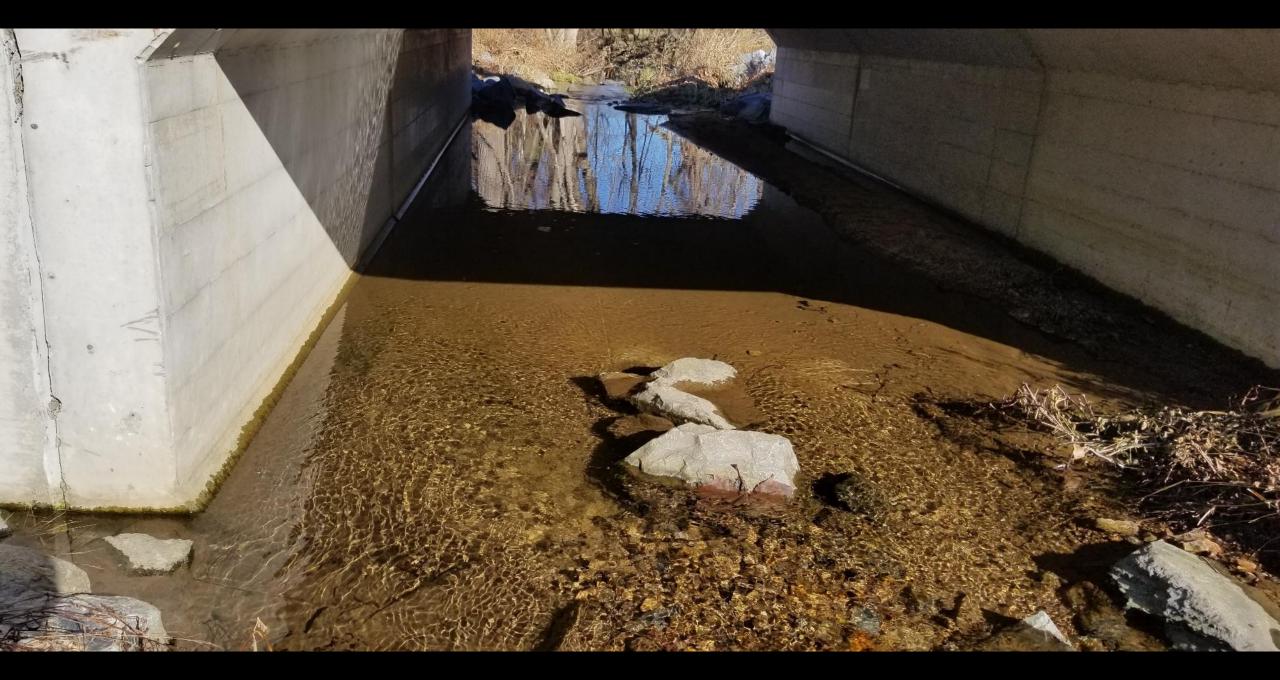
-Structure not depressed properly into stream bed.
-Structure installed too high, causing stream to narrow
-Lack of streambed material causes "velocity barrier"

-Lifespan of crossing that lacks material?

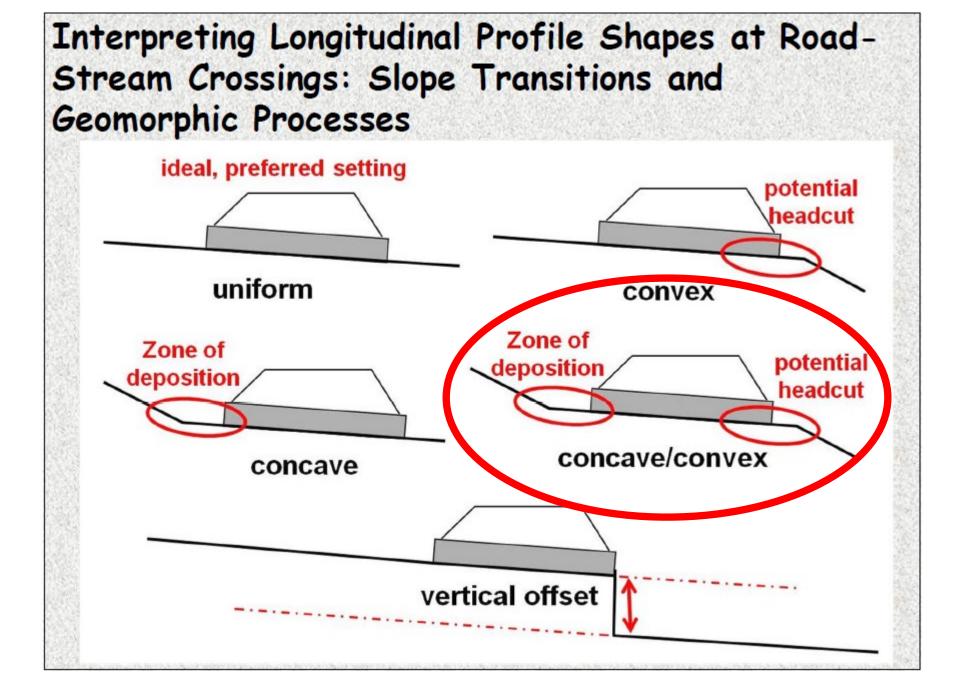
-100% Bankfull width

-Designed and Constructed to accommodate AOP??

-Stream drops steeply into new structure

-Structure is set flat, causing a "concave/convex" profile

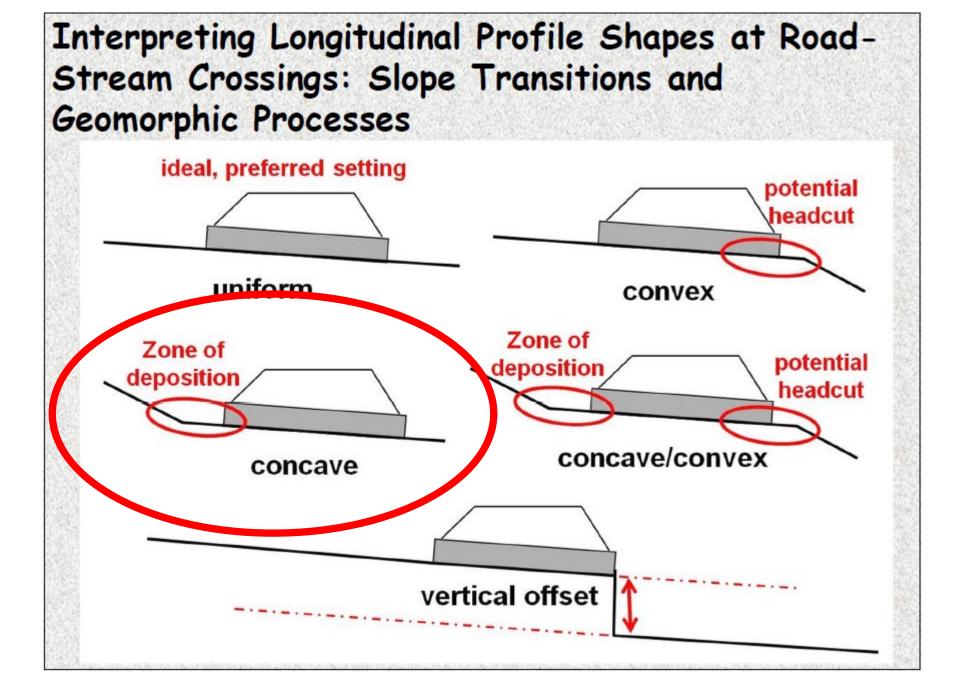
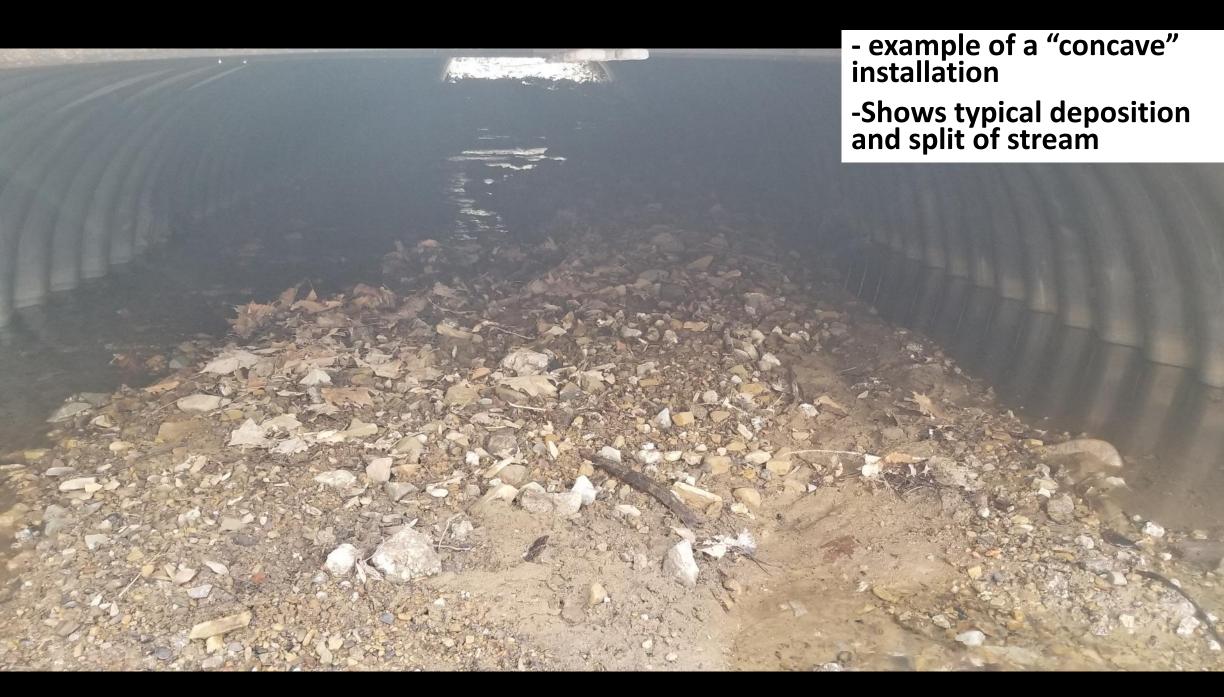
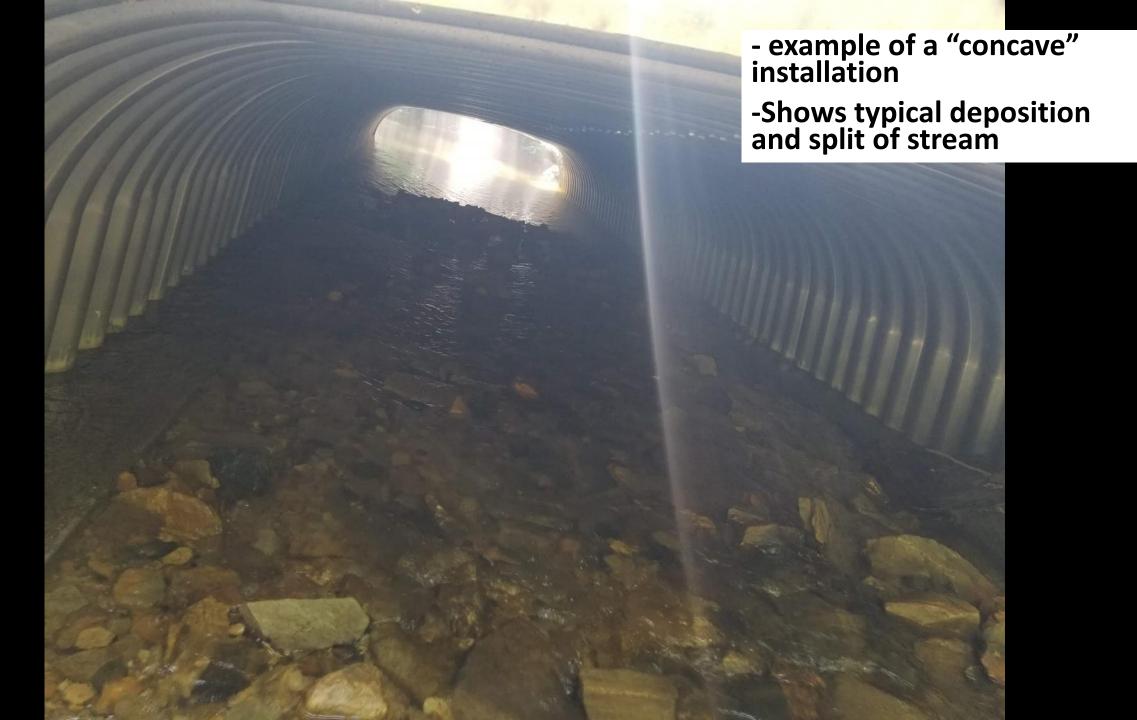
-No streambed built through the structure

-Lacks bank margins and low flow channel

-AOP barrier downstream

-Potential for head cut

-Stream drops steeply into new structure

- -Stream is flat through structure
- -Stream drops again leaving the structure
- -Structure is set flat, causing a "concave/convex" profile

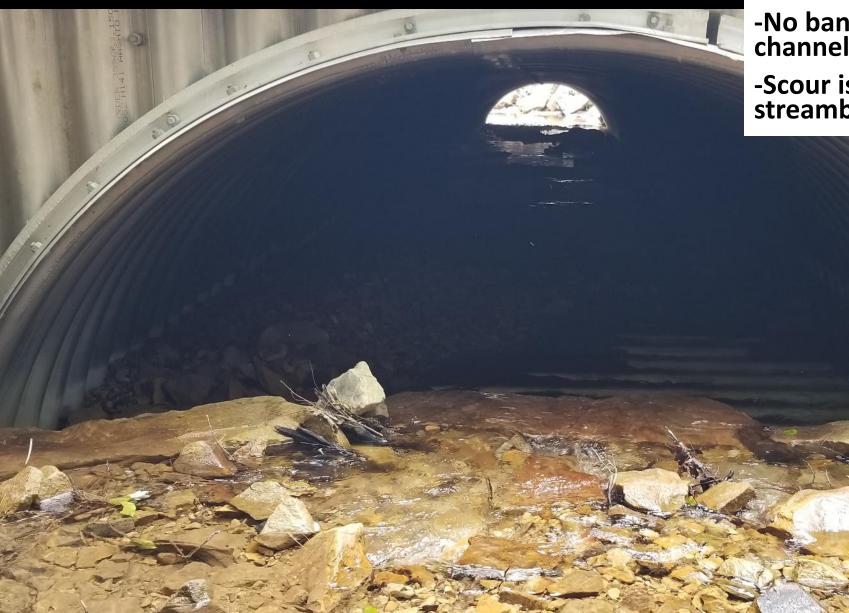
-Lacks sufficient streambed material

-No bank margins and low flow channels

-Scour is greater than depth of streambed material

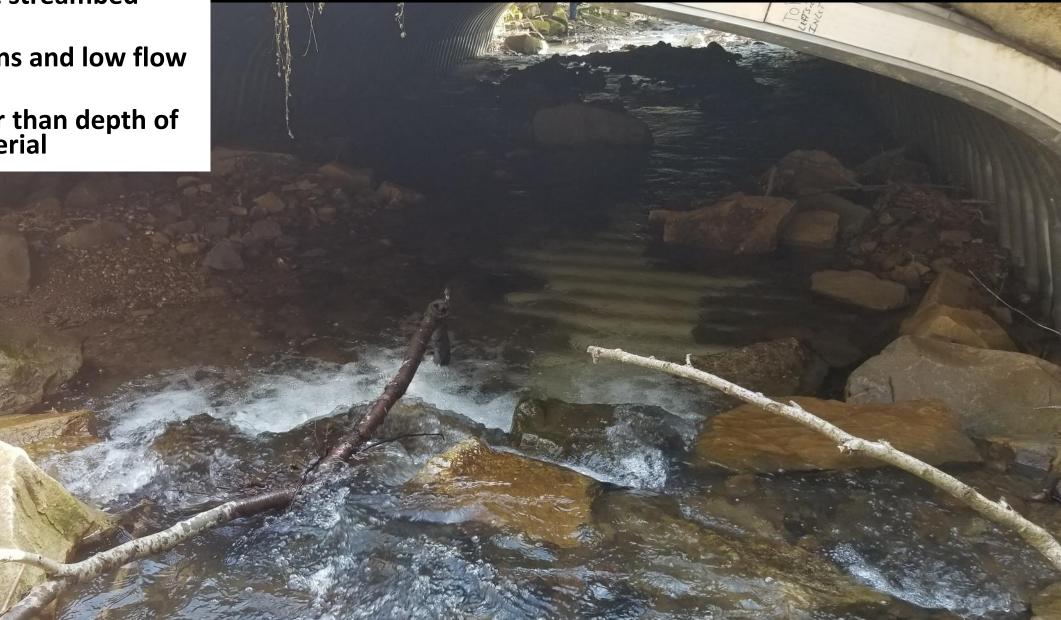
- -Lacks sufficient streambed material
- -No bank margins and low flow channels
- -Scour is greater than depth of streambed material

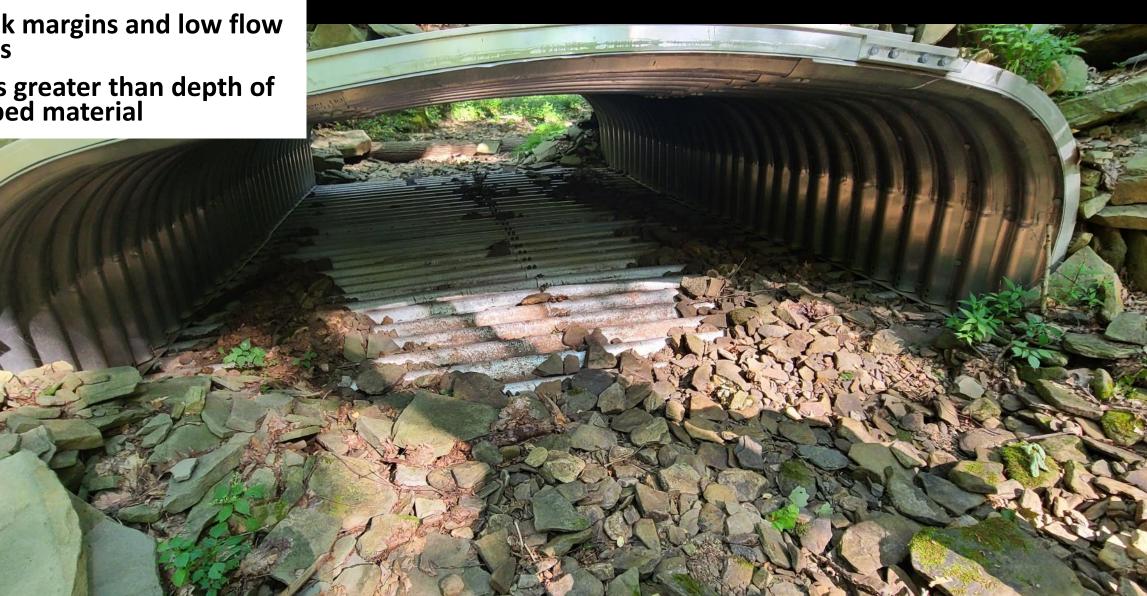
- -Lacks sufficient streambed material
- -No bank margins and low flow channels
- -Scour is greater than depth of streambed material
