DGLVR Webinar 2019 Project Sharing Session Summaries

Project Sharing Session Summaries

- Held three “Project Sharing Sessions” around the State this spring where CDs presented completed and upcoming projects.
- Purpose today is to share a quick summary of some of the project presented at these sessions.

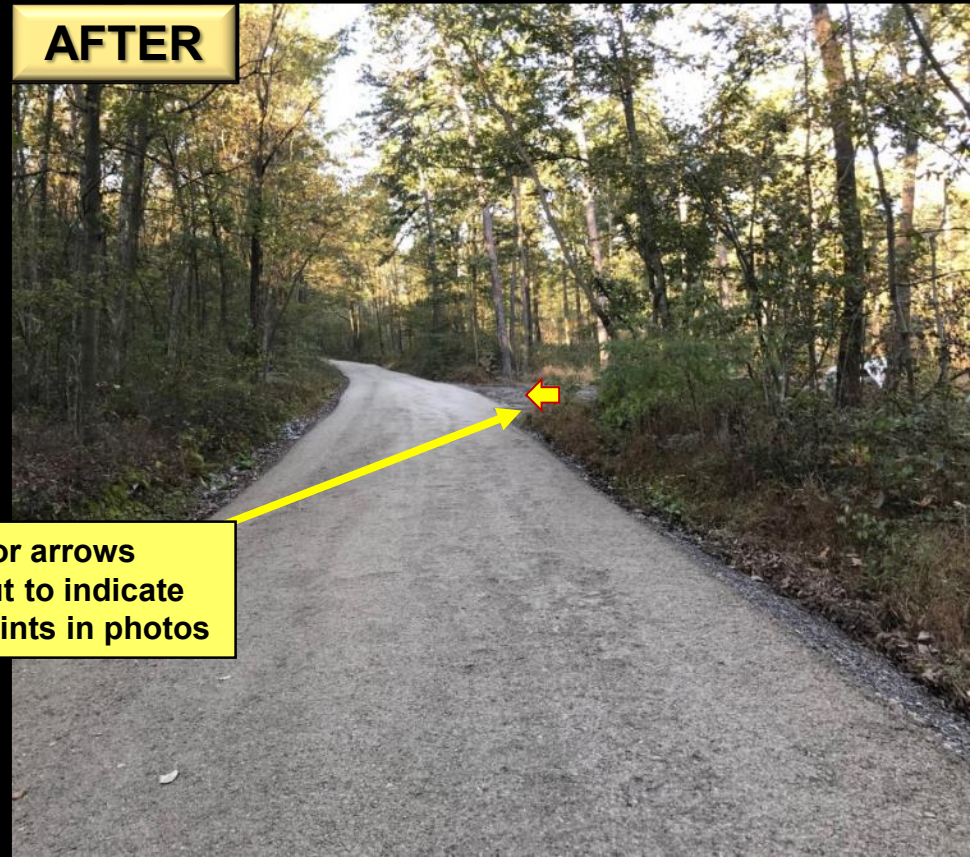
- Huge multi-year project on 2.4 miles of road that was rutted and nearly impassable.
- **2016:** 23 shallow crosspipes
- **2017:** 20 shallow crosspipes + 1,200' underdrain
- **2018:** 10,000+tons of base material added
- **2019:** Planned ~1.2 miles of DSA placement

This is a multi-phased, multiple year project that started in 2016. The entire project site is 2.4 miles long. Before work began on this project, the road was very rutted and almost impassable. Water would channelize in the wheel ruts and bypass the existing drainage pipes. The township added a lot of material before the first phase of the project started in summer 2016 with drainage work.

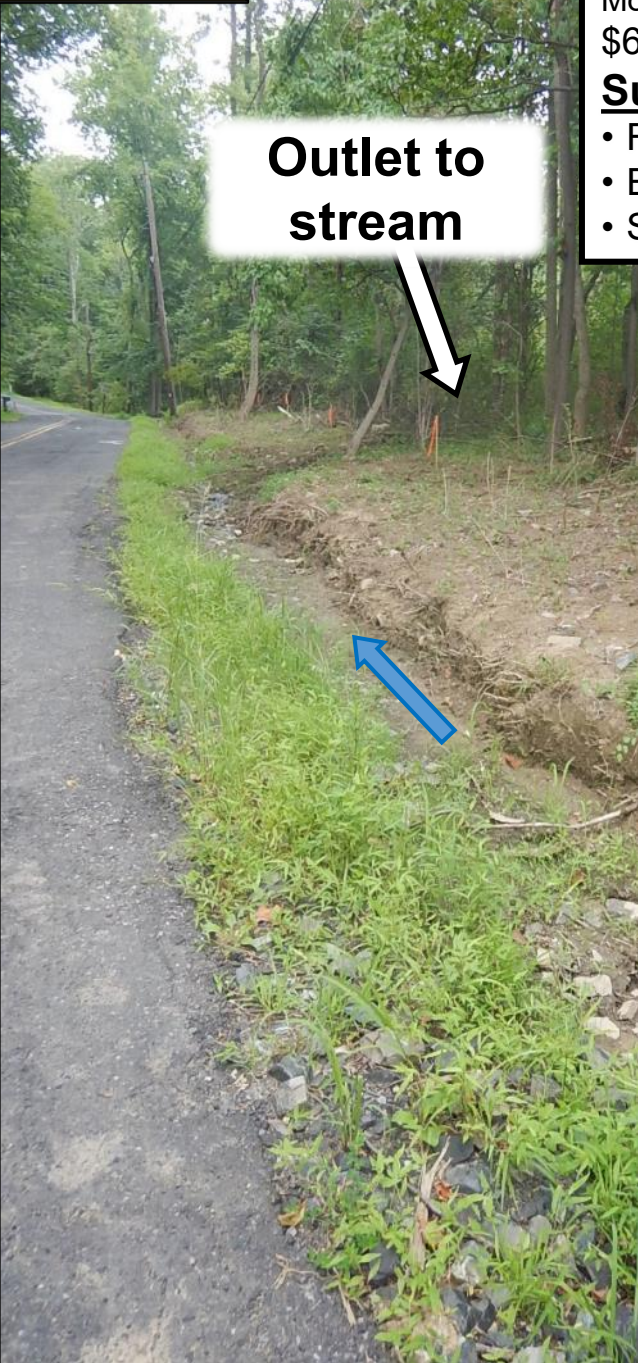
**Outlet to
stream**

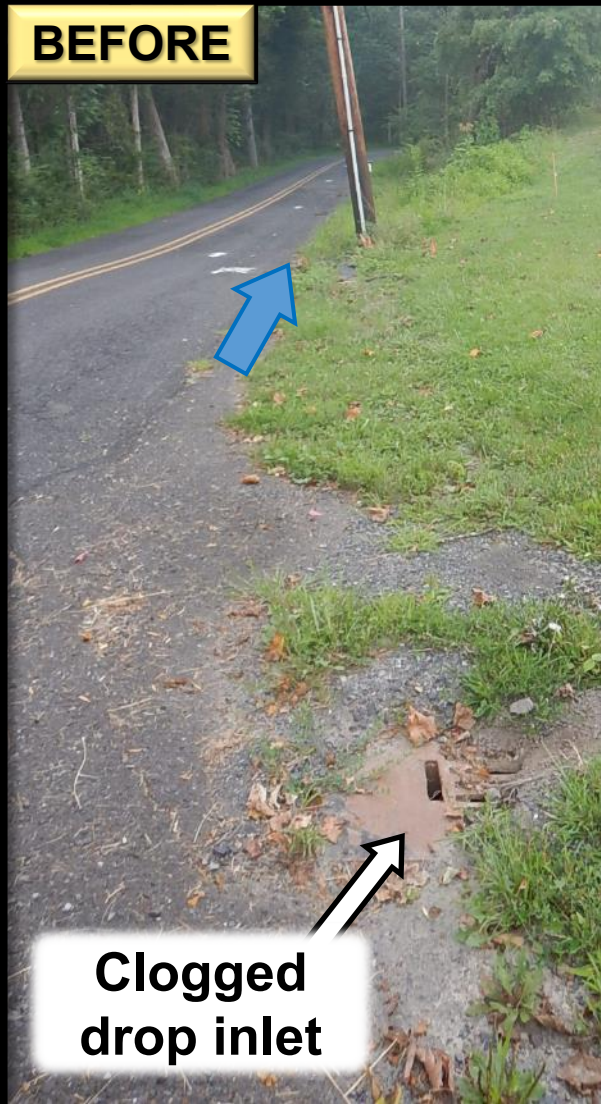
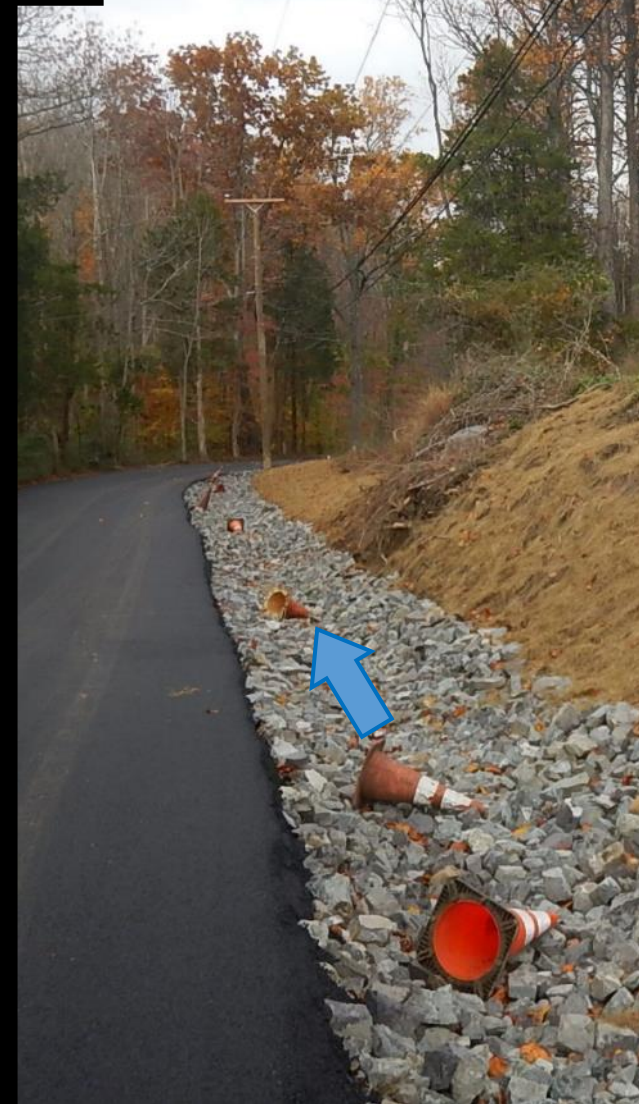
- Removed failing storm sewer
- Established stabilized ditch with new outlets
- Significant bank and utility work

**Clogged
drop inlet**

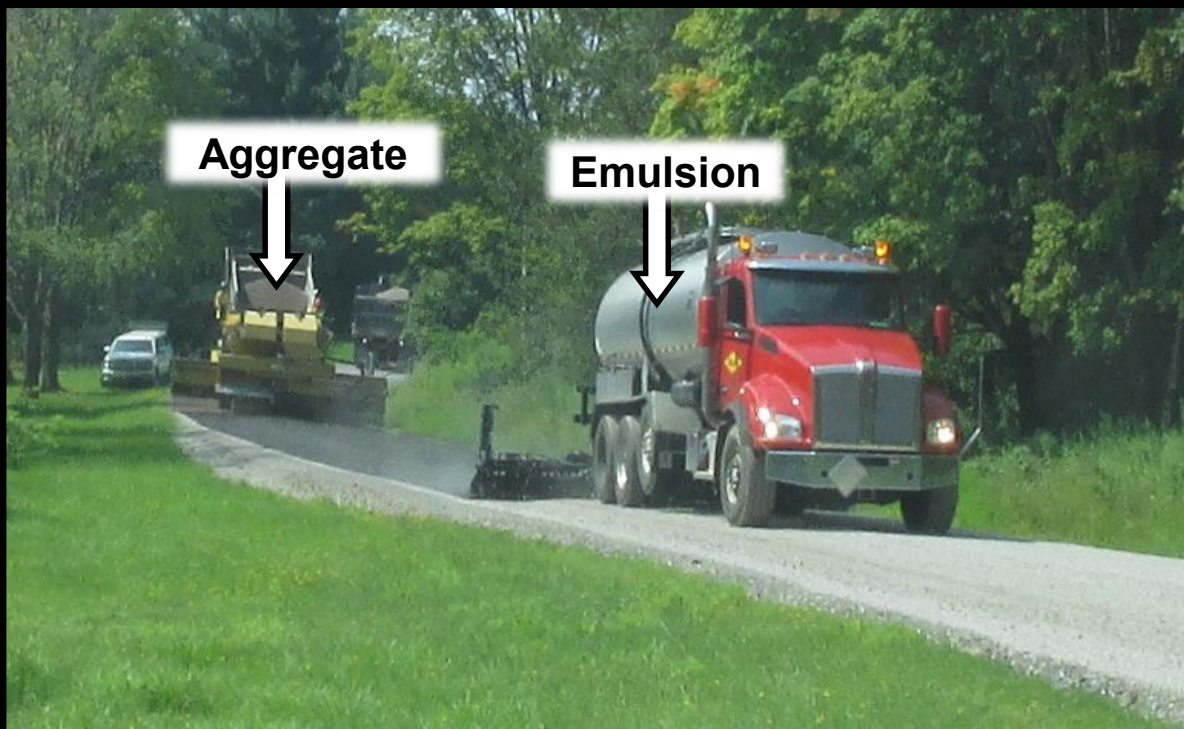
- Summary:**
- COUNTY owned road in very poor condition
 - 7 replaced and 3 new pipes
 - 1,800 tons 2RC placed over road, then Full Depth Reclamation, then tar and chip application

2RC

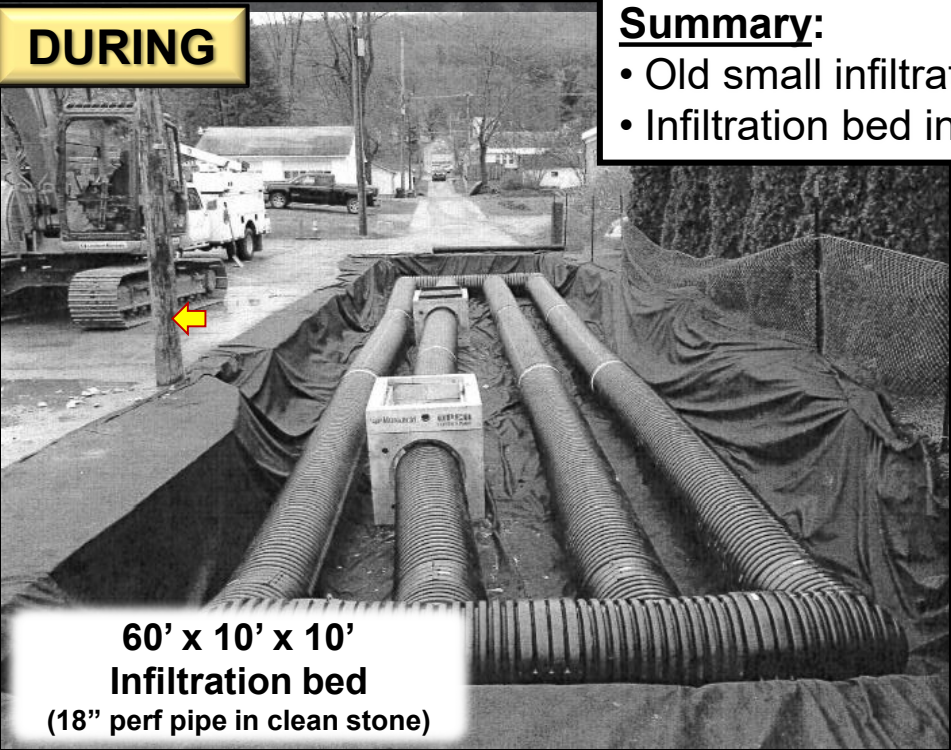
2018 LVR **1/1**
Cumberland County, Wood Ave
\$18K Grant, \$16K In-kind
Summary:
• Old small infiltration cistern failing
• Infiltration bed installed under road

60' x 10' x 10'
Infiltration bed
(18" perf pipe in clean stone)

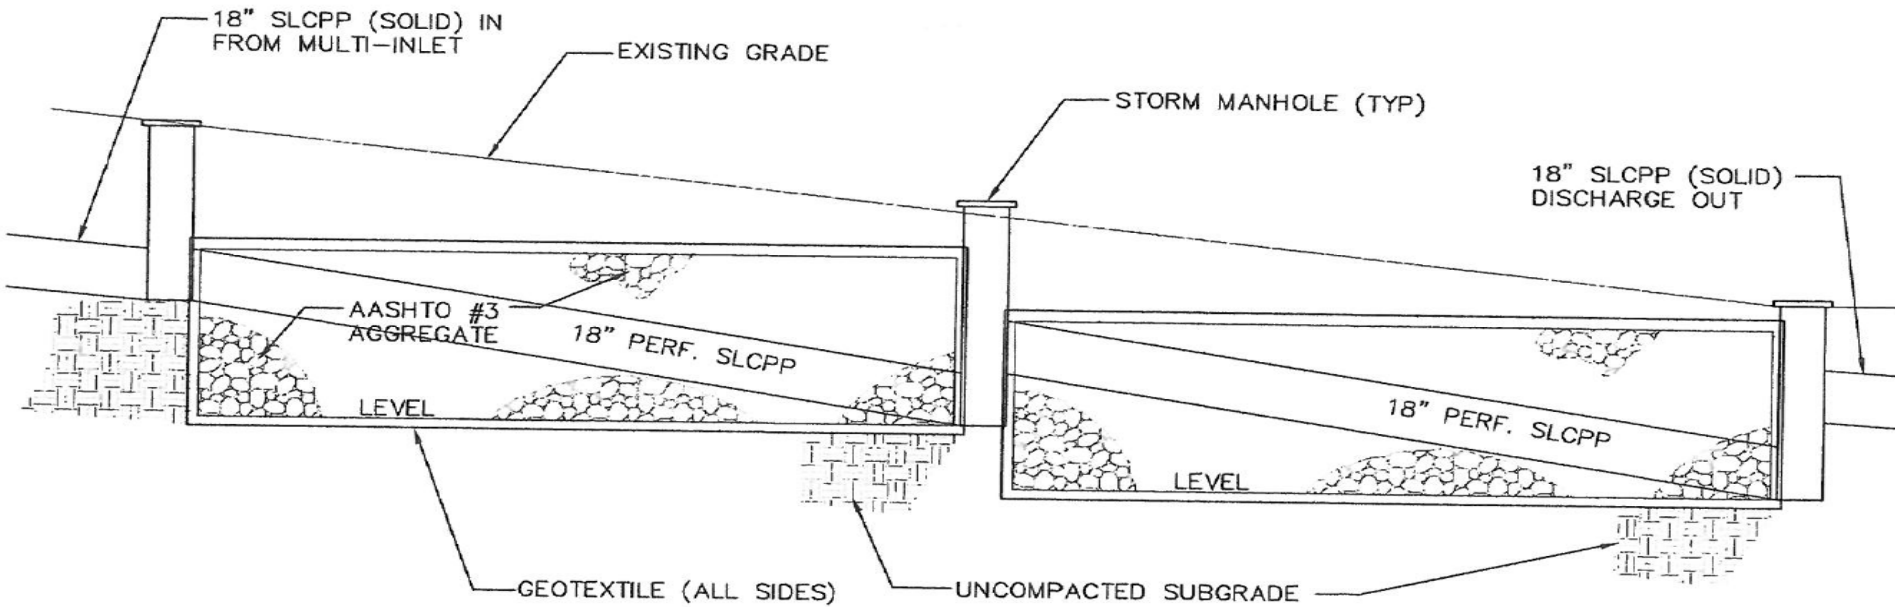
SUBSURFACE INFILTRATION BMP

NOT TO SCALE
SD\SD080

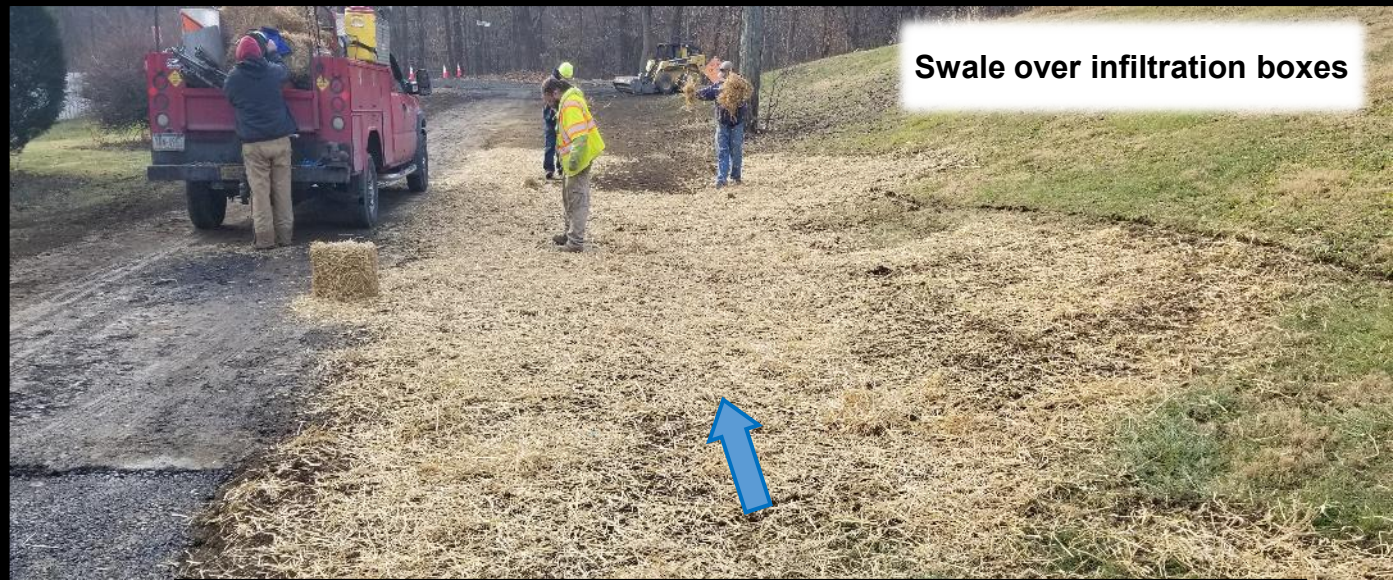
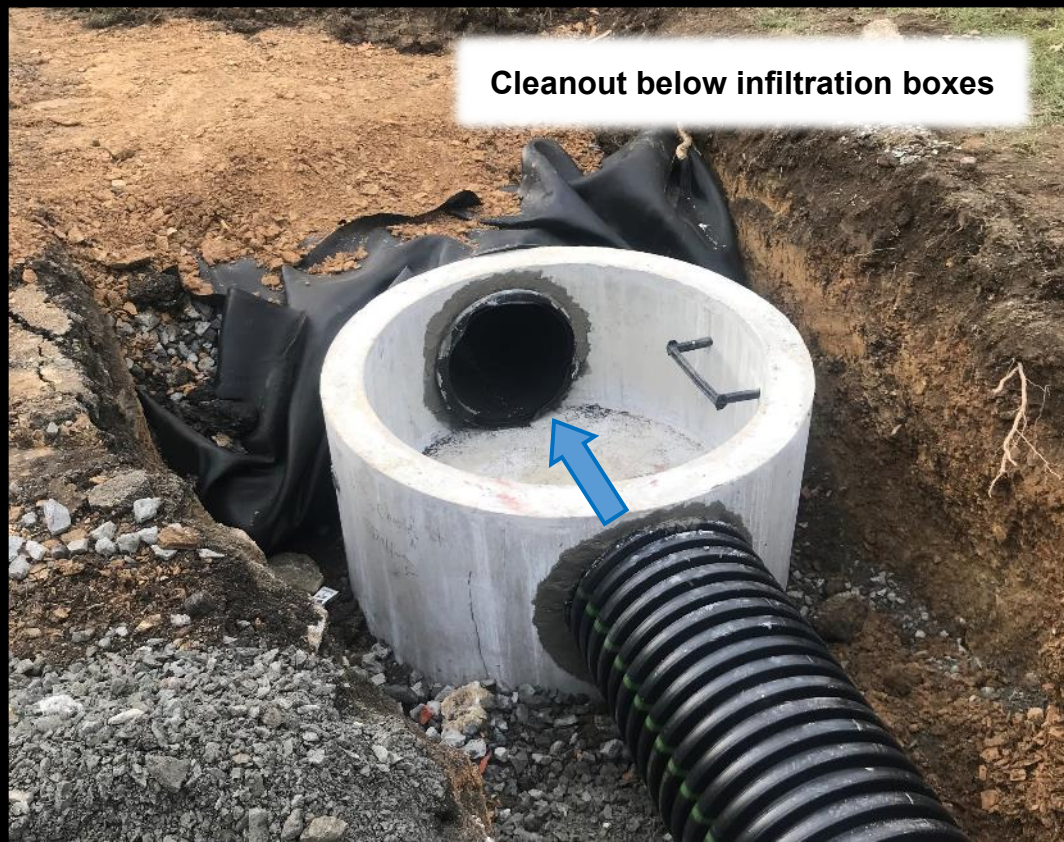
Swale over infiltration boxes

Cleanout below infiltration boxes

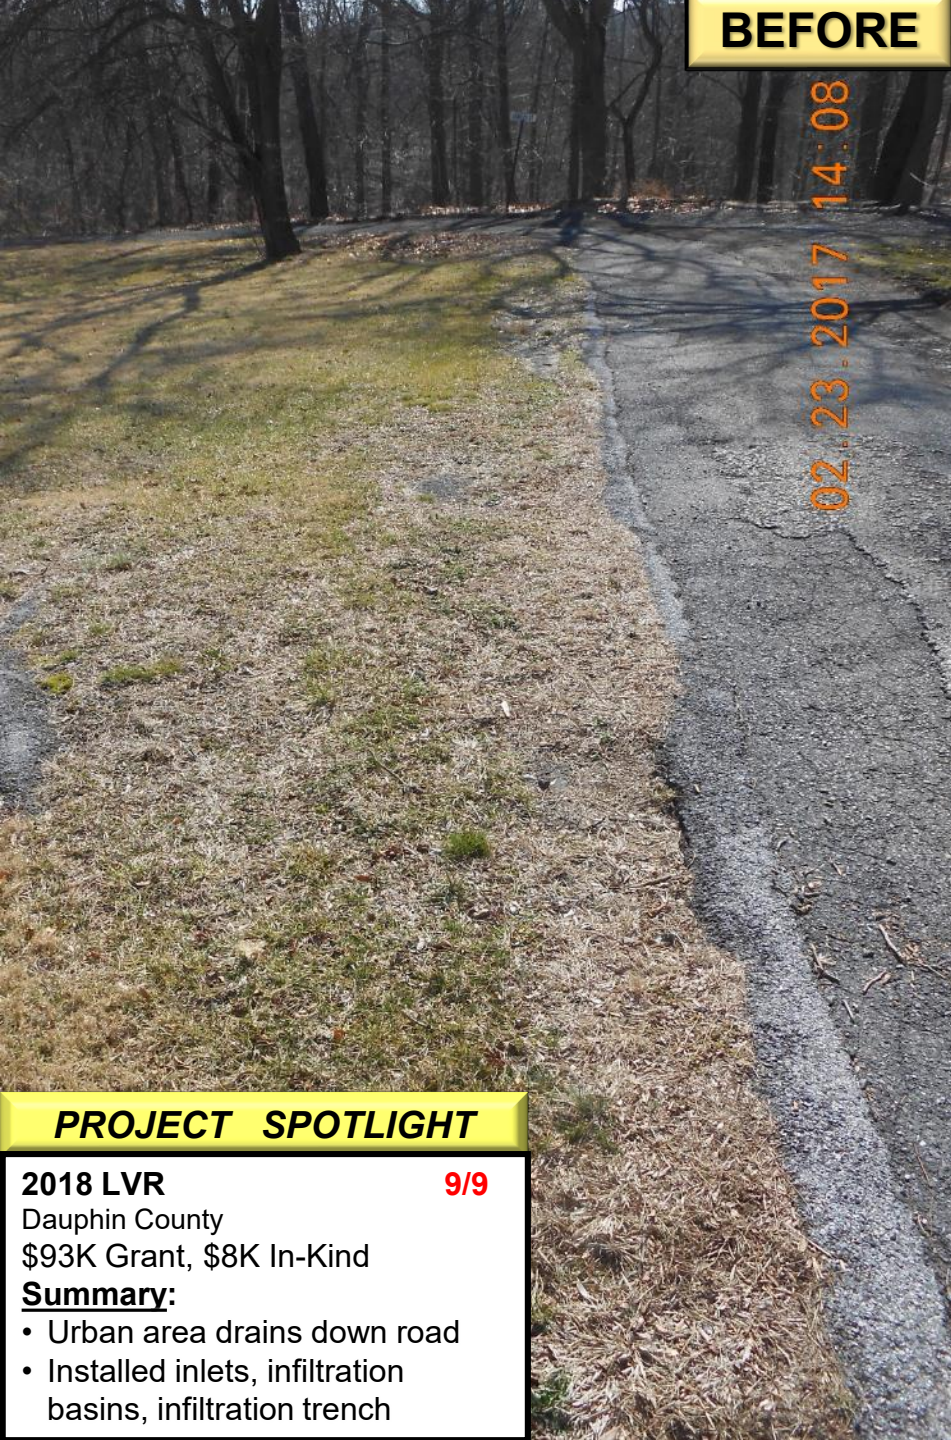
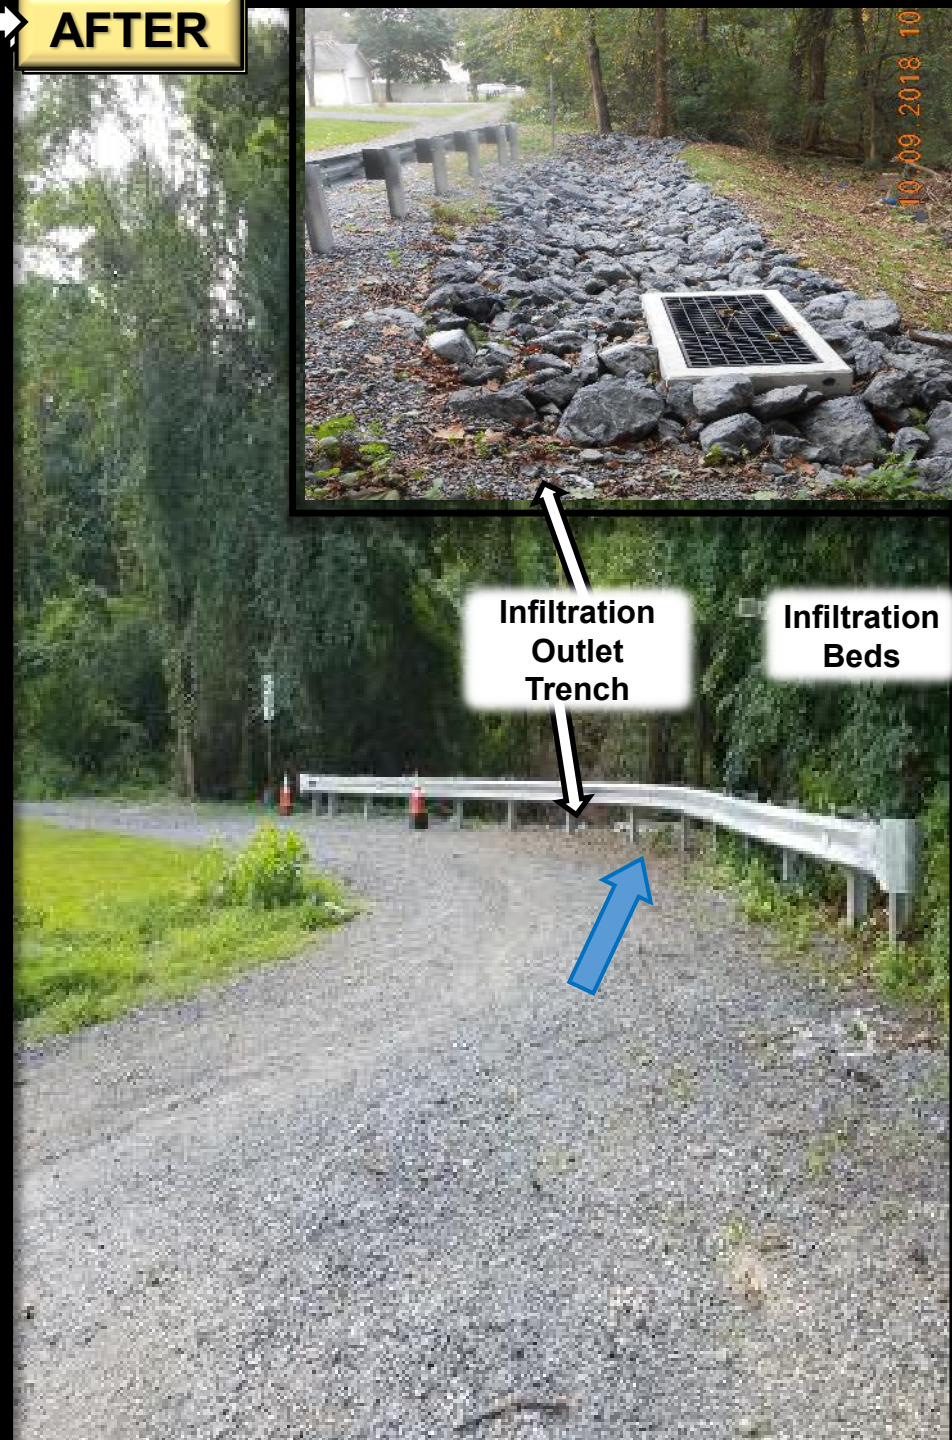
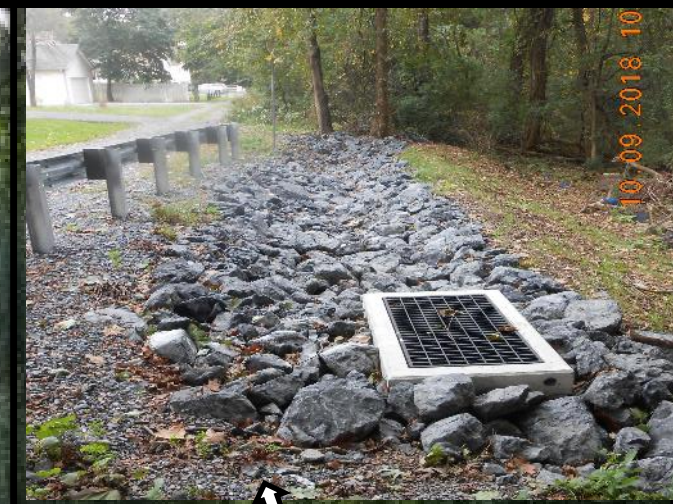
Infiltration
Outlet
Trench

Infiltration
Beds

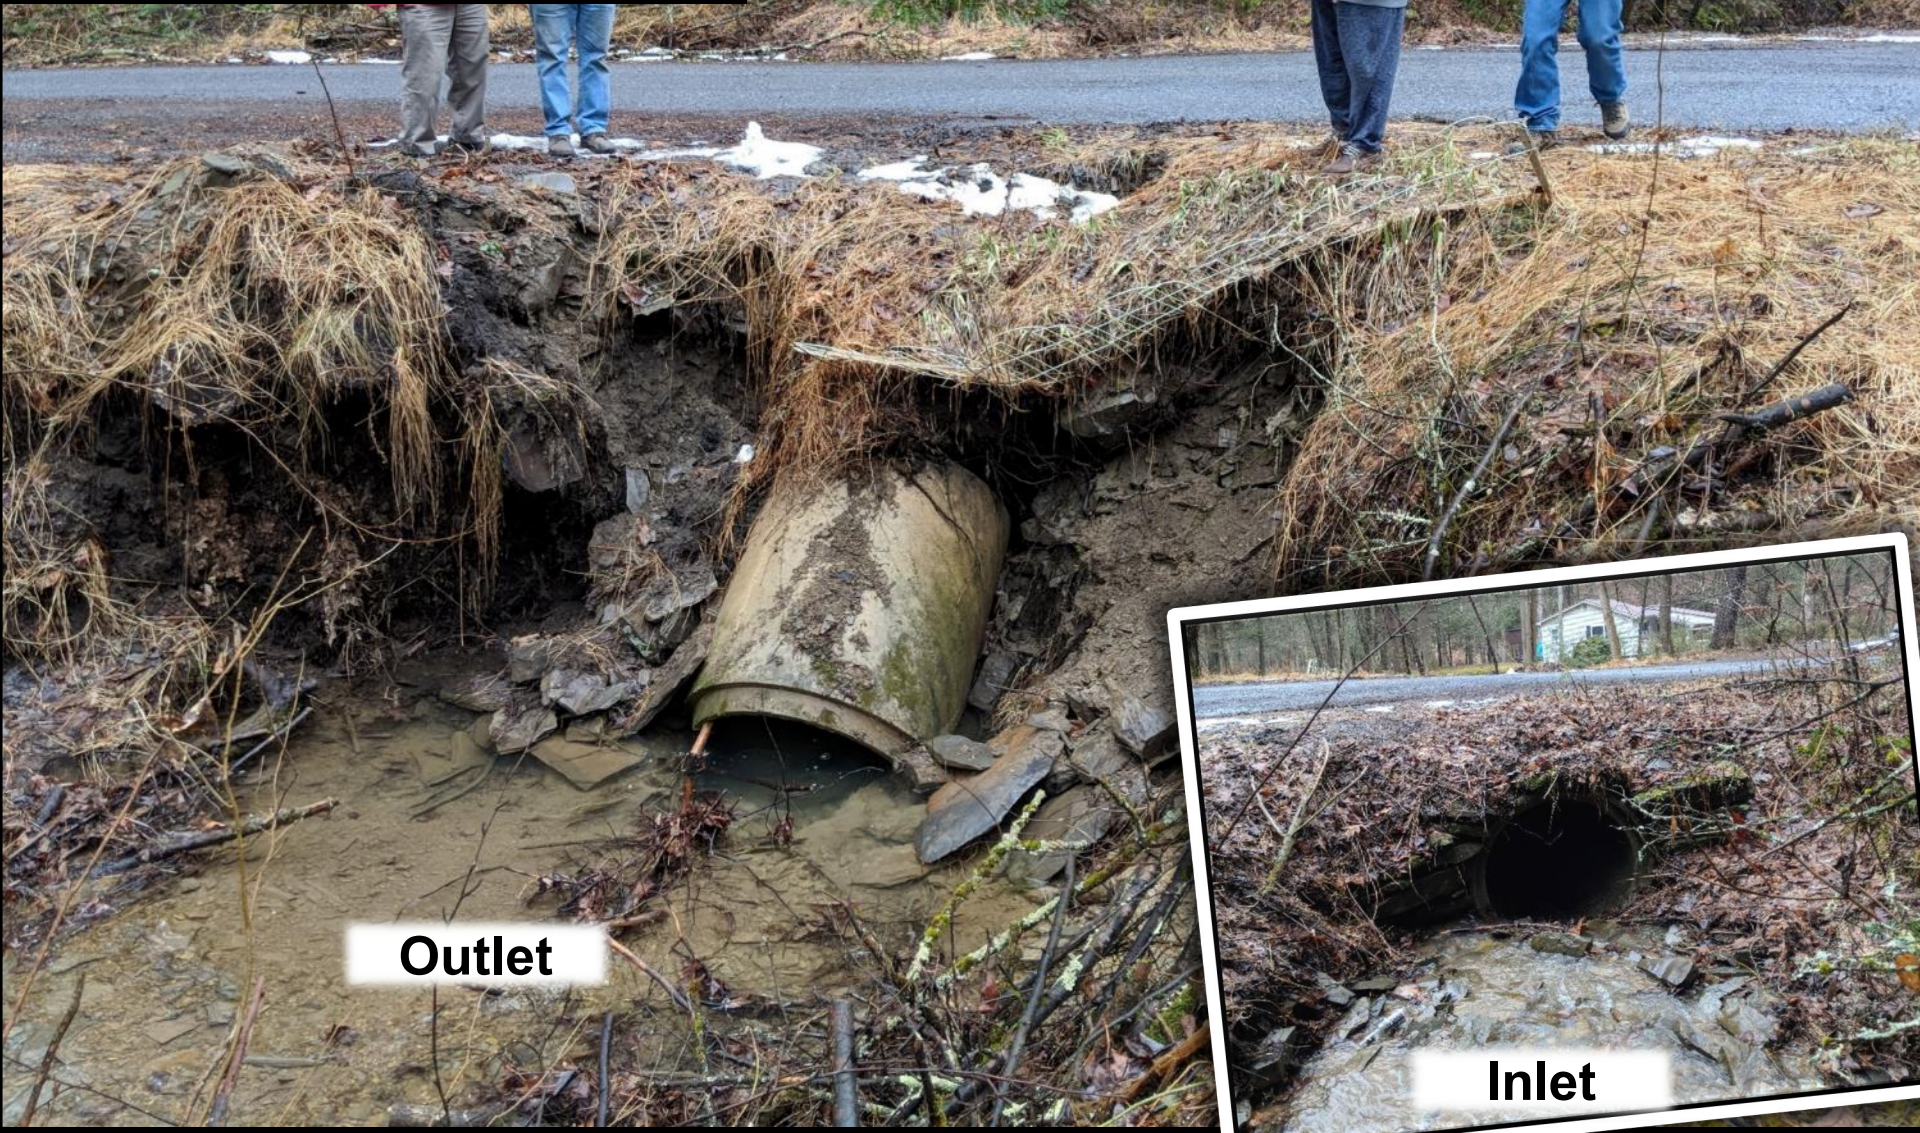
- “Minor” crossing issues
- 3’ pipe in 11’ bankfull channel
- Proposed 12’ arch pipe with baffles

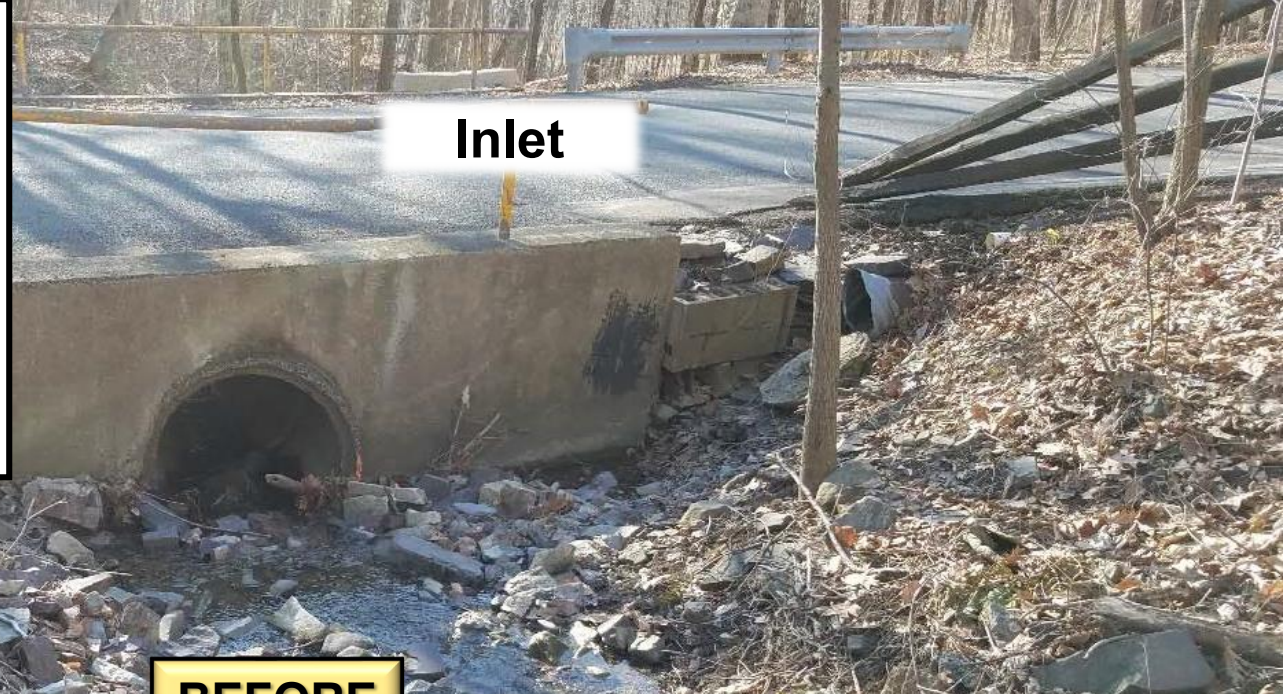
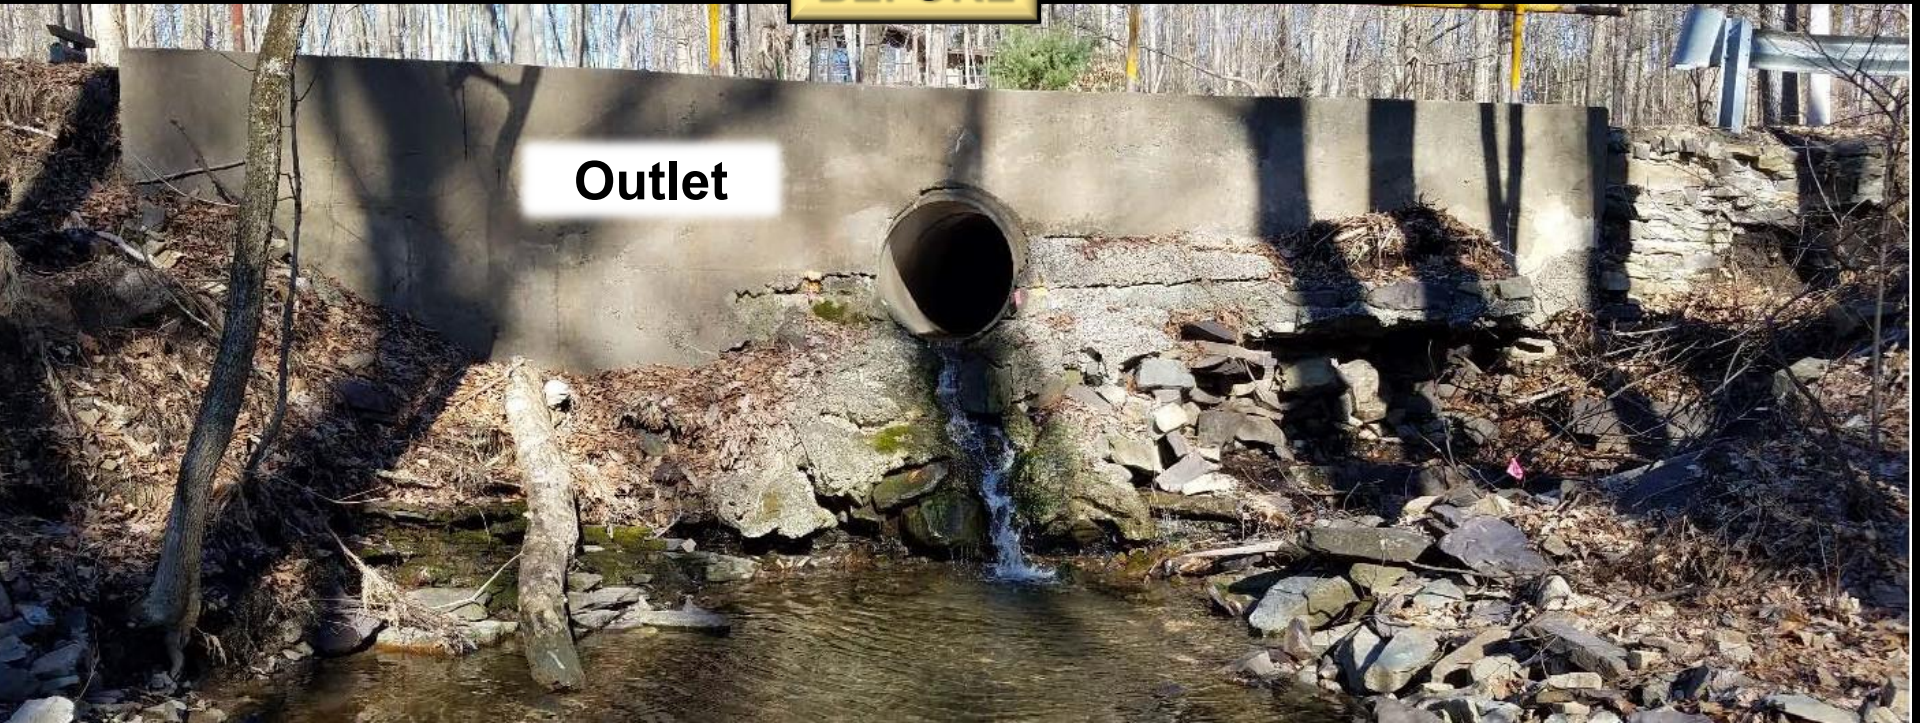
- Proposed 12' bottomless arch on concrete footers due to ~10" channel slope
- Shallow bedrock, multiple channels converging.
- Significant grade controls required

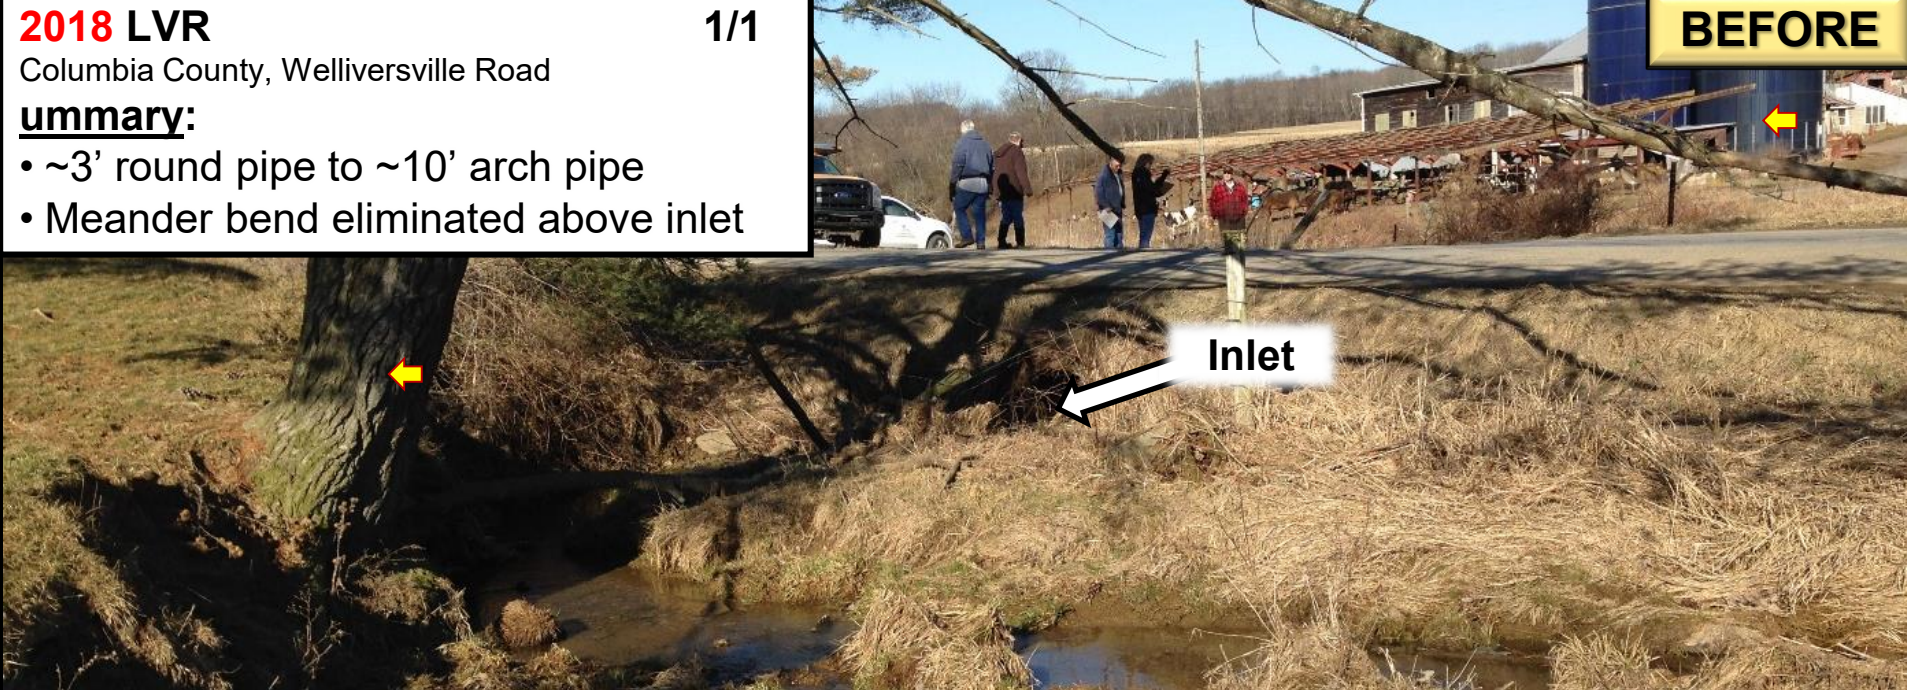
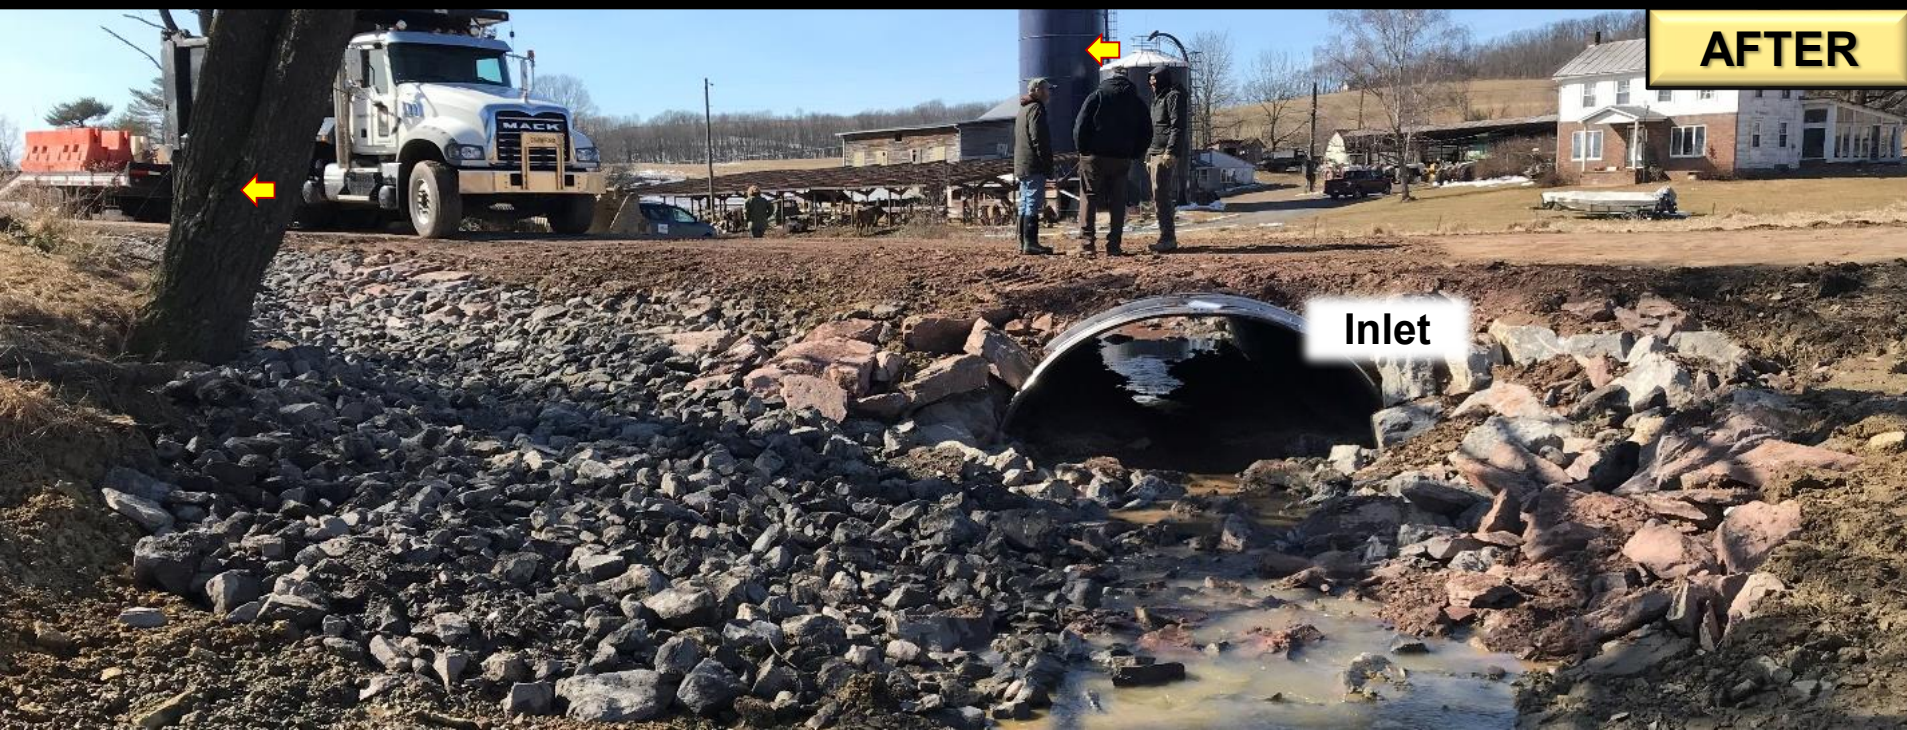
- ~3' round pipe to ~10' arch pipe
- Meander bend eliminated above inlet

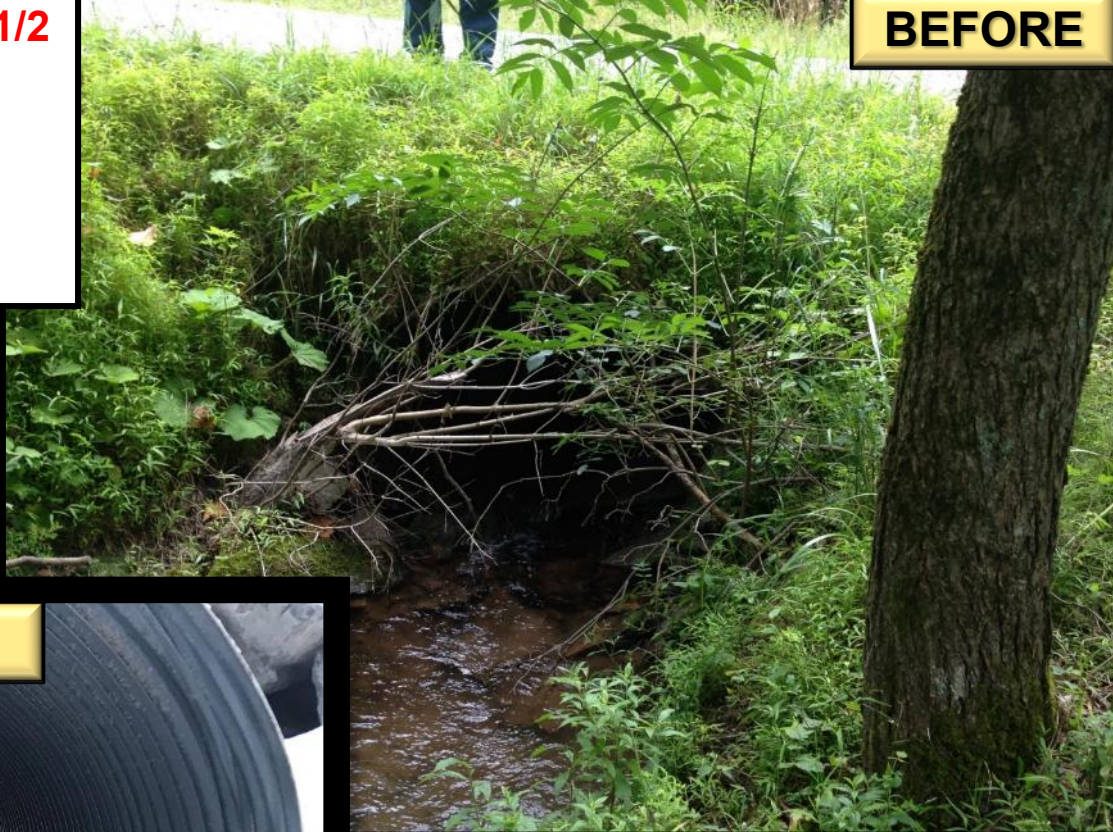
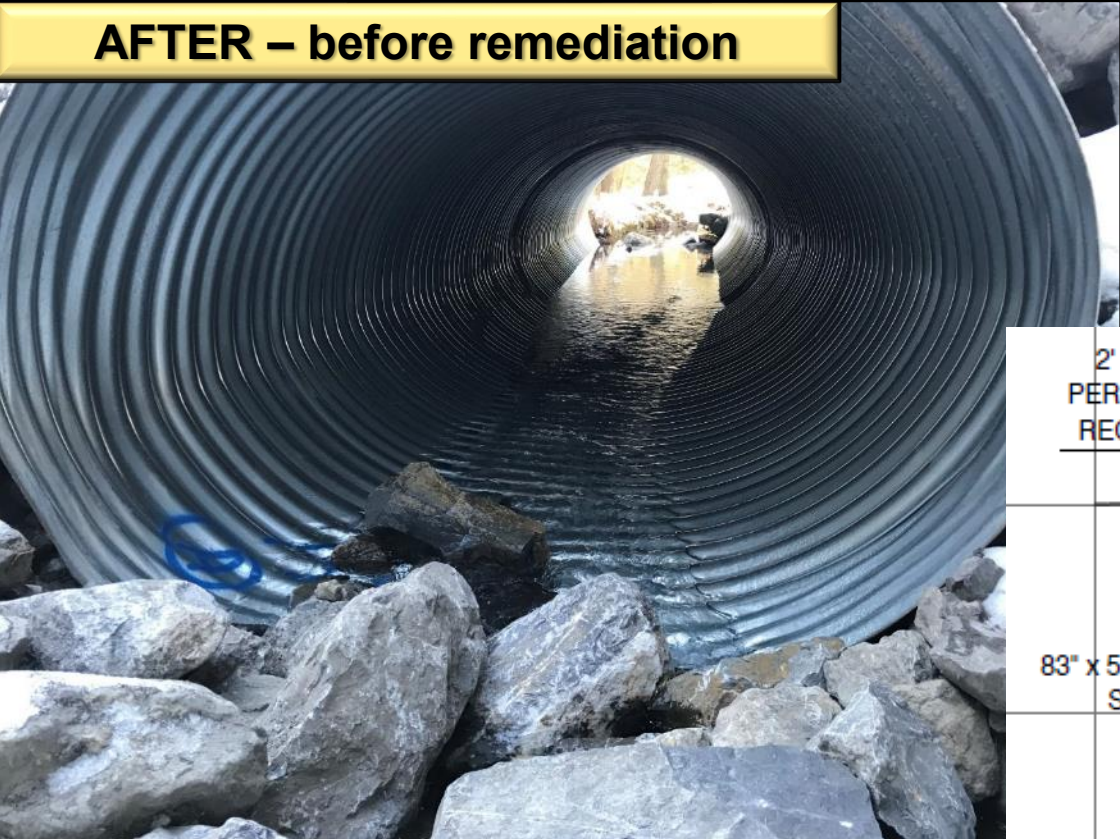
- 4' round to 7' squash pipe in EV Stream
- Project done without notification
- No material in pipe

AFTER – before remediation

- CDGRS and TU assisted CD with remediation and placing material in pipe

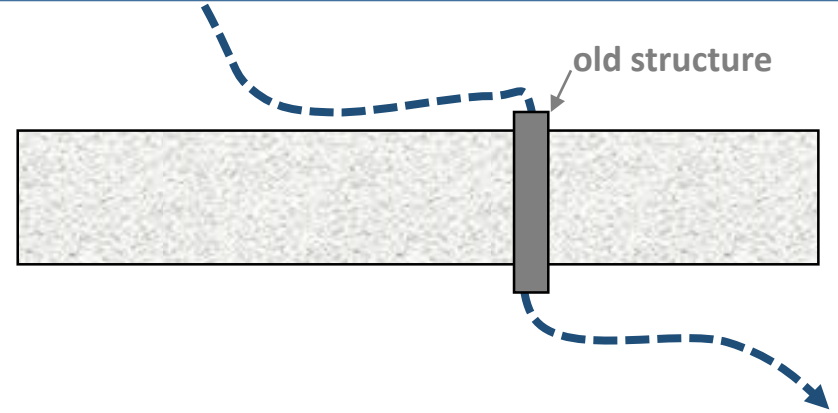
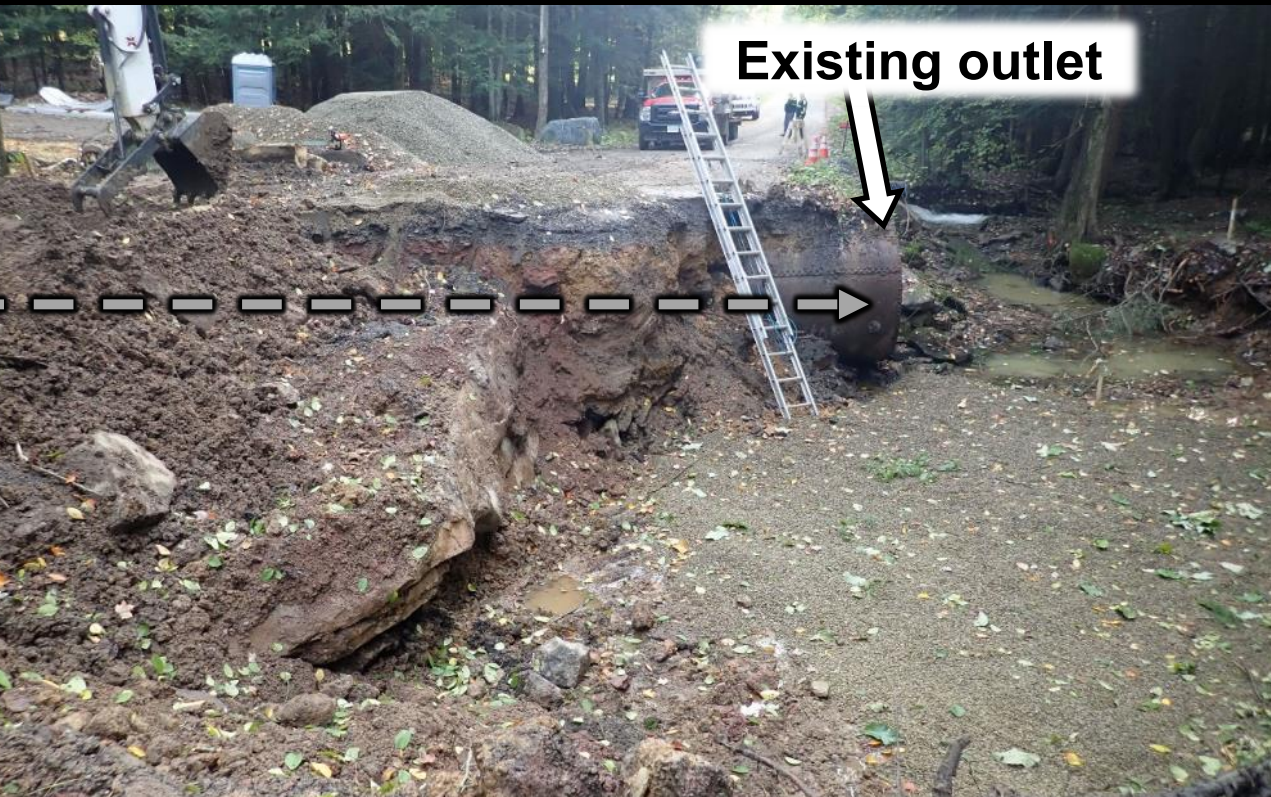
New structure eliminates multiple 90 degree turns and aligns channel. As result, structure is 92' in length.

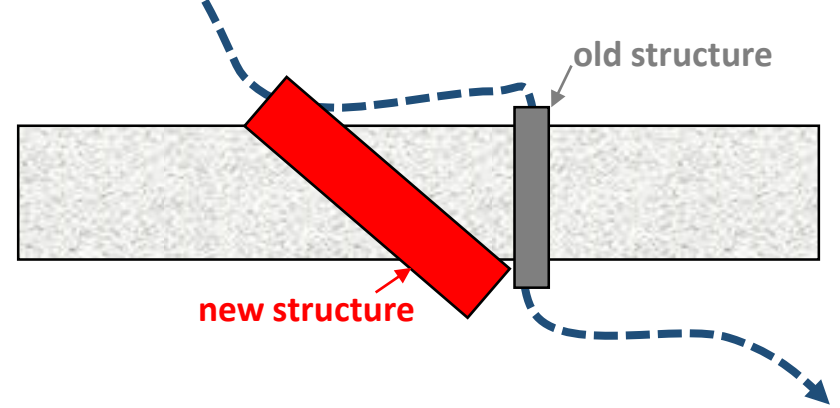
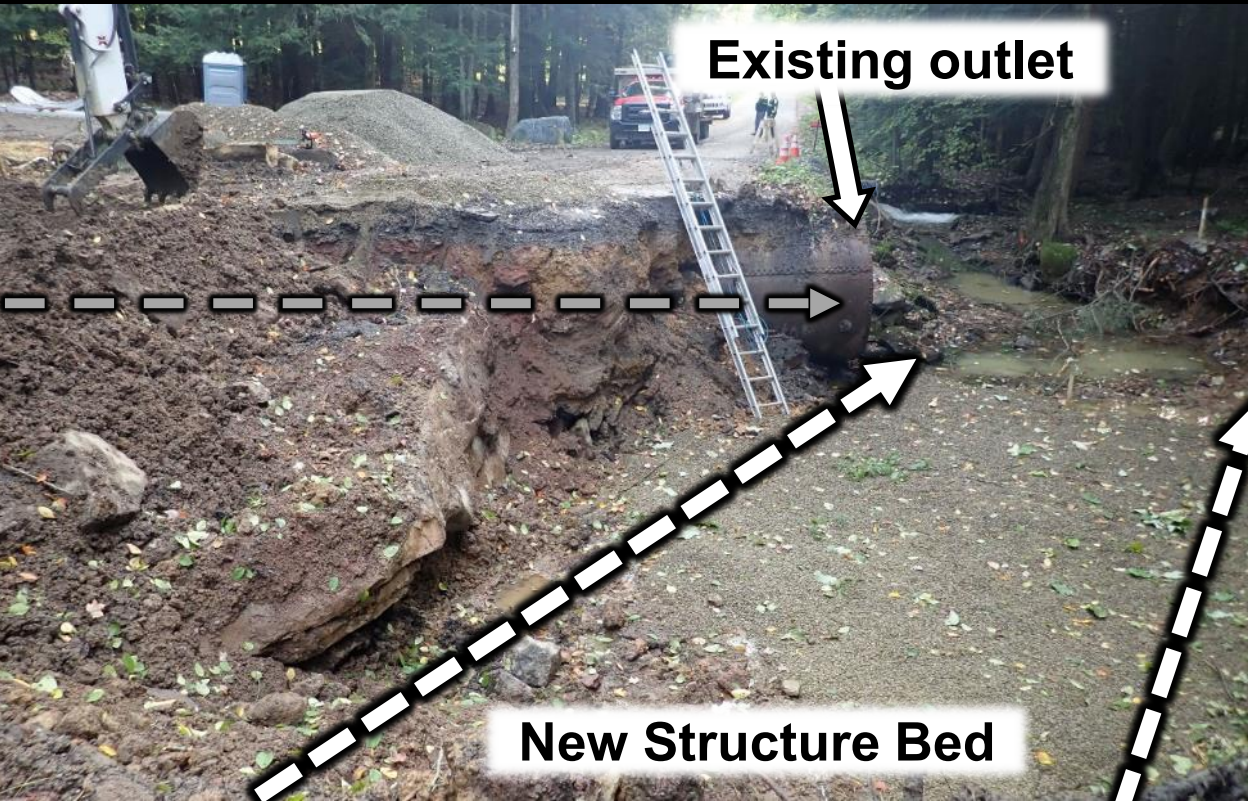
New structure eliminates multiple 90 degree turns and aligns channel. As result, structure is 92' in length.
