DGLVR Webinar 2019 Project Sharing Session Summaries

Project Sharing Session Summaries

- Held three “Project Sharing Sessions” around the State this spring where CDs presented completed and upcoming projects.
- Purpose today is to share a quick summary of some of the project presented at these sessions.

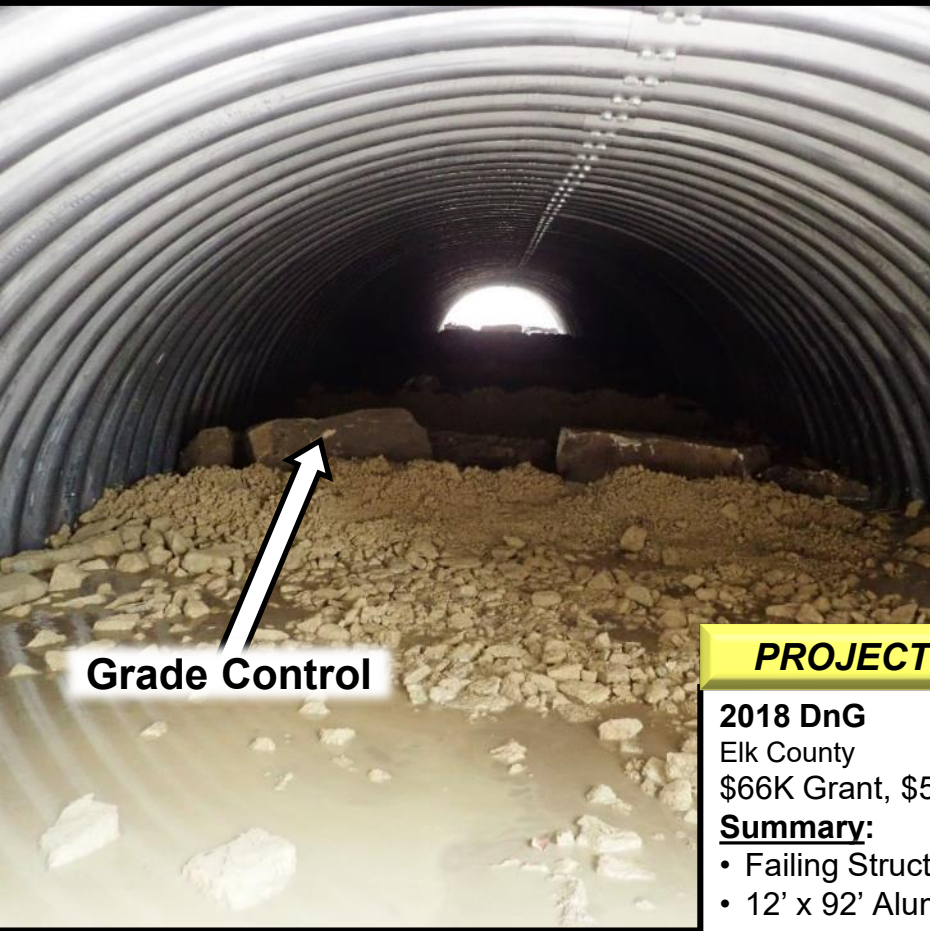
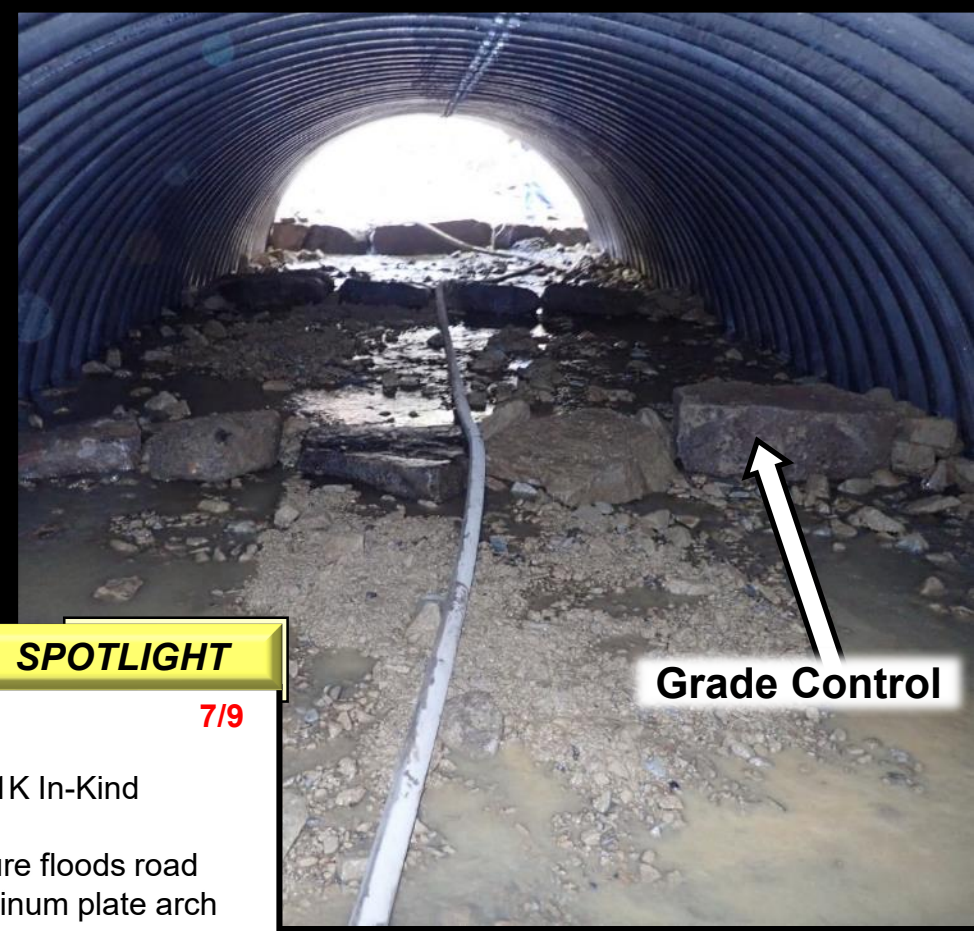
- Grade Control above, below, and in structure
- Material in Structure
