Worksite in Focus

Fulton County Dutch Corner Road

4/13/04

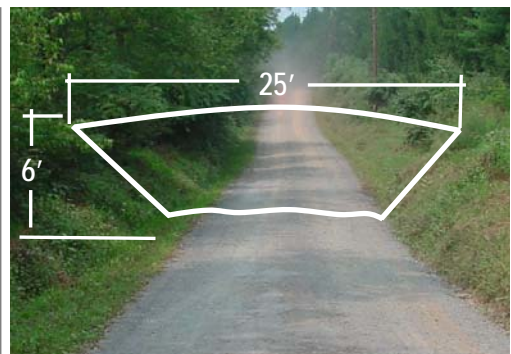
Raising the road elevation to the elevation of the surrounding landscape was impractical because of the amount of material required (above).

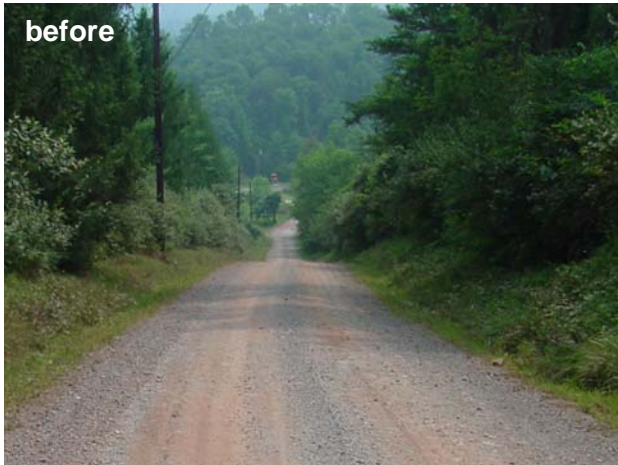
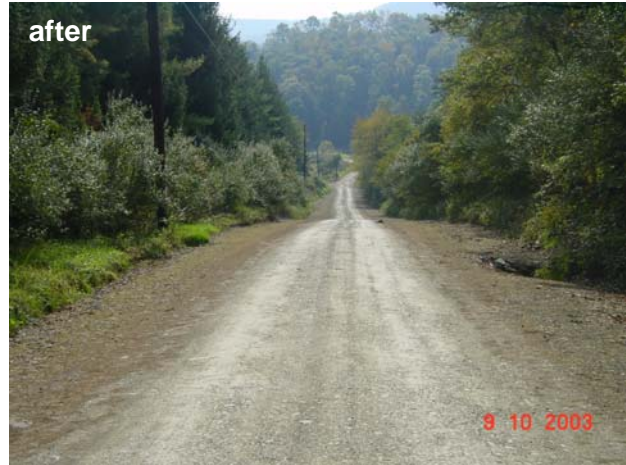
before

after

Before and After Shale Placement. Before, severely entrenched road slopes steeply to stream at the bottom of the hill. After, cross-pipes are added to divide drainage and reduce concentrated flow and the road elevation is raised 2' to cover the new pipes.

Road profile. Shale was placed on steep entrenched areas to a maximum depth of 2 feet to obtain adequate cover on new crosspipes. Road surface was topped with Driving Surface Aggregate (DSA) for improved performance.

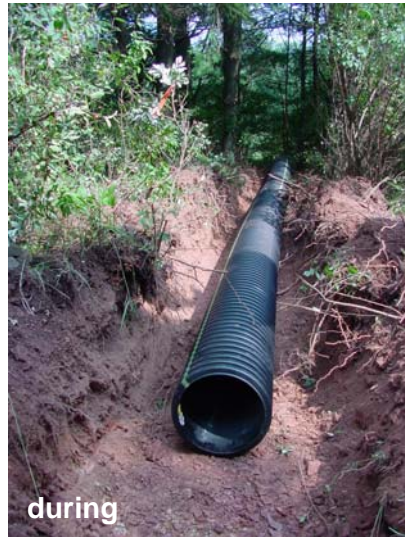
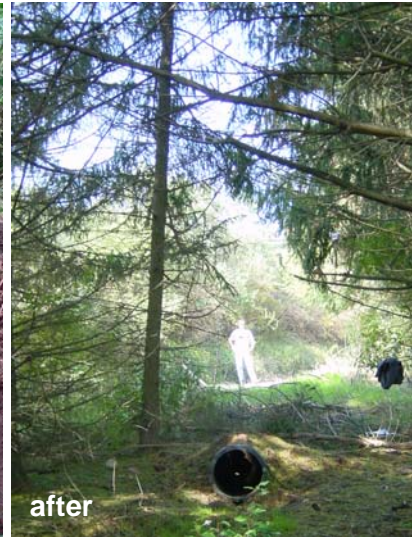
during

after

Pipes Through the Bank. Note the depth of the trench during construction. After construction the pipe has been covered and stabilized with vegetation.

Adding crosspipes and installing pipes through the bank. 3 existing crosspipes were replaced and 9 new drainage pipes were added. 3 of the 9 were installed through the bank. Increased road drainage capacity minimizes concentrated flow before sufficient volume and velocity can build to strong erosive force.
