Worksite in Focus

Potter County Horseshoe Road

6/10/04

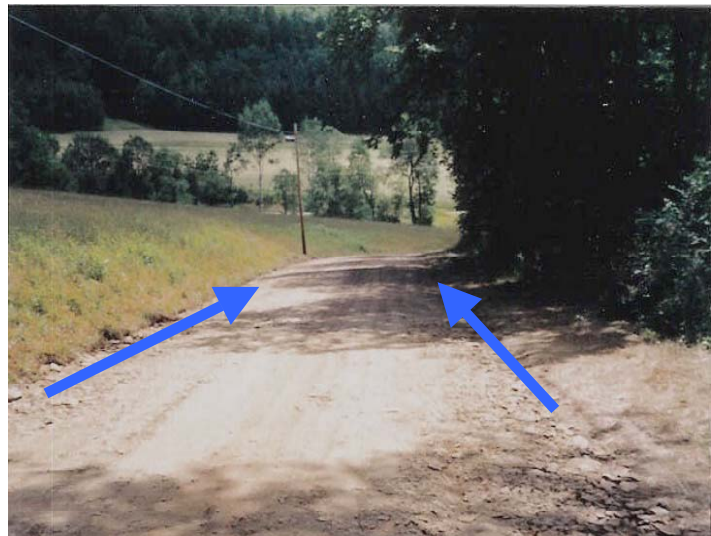
Routine maintenance operations and the wear and tear of traffic had the cumulative effect of lowering the road elevation in relation to the surrounding terrain (see photo). The resulting entrenched road trapped road drainage. Confined by the road, this water concentrated in parallel ditches and gained velocity. As the volume and velocity increased, more and more valuable road material was washed away, polluting nearby Pine Creek.

Before: The entrenched road trapped road drainage resulting in fast-moving concentrated ditchflow. This water eroded road material and deposited it directly into Pine Creek.

Adding a cross-pipe: Installing a new cross-pipe on the road provided an extra drainage outlet and shortened the flow length of parallel road drainage. By minimizing the distance water has to travel before it is removed from the road corridor, the velocity and erosivity of the water are reduced.

Adding perforated underdrain: Underdrain, or drain tile, was added in the ditch to collect water flowing from spring seeps. This eliminated perennial ditchflow and corrected the soft road base problem.

Filling the road: The elevation of the road was raised by filling the road profile. The added elevation eliminated the need for parallel ditches and allowed drainage to sheet flow into the surrounding terrain through vegetated buffers, removing sediment-laden surface flow to Pine Creek.

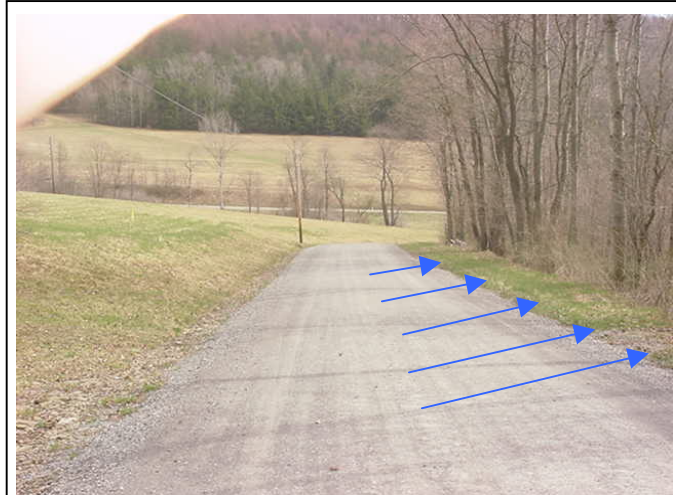
After: The road profile was raised eliminating ditchflow on the downslope side of the road. Drainage that was trapped on the entrenched road can now sheet flow freely off the road into surrounding vegetation. Because the water does not have the opportunity to gain velocity, its erosive potential is greatly reduced.

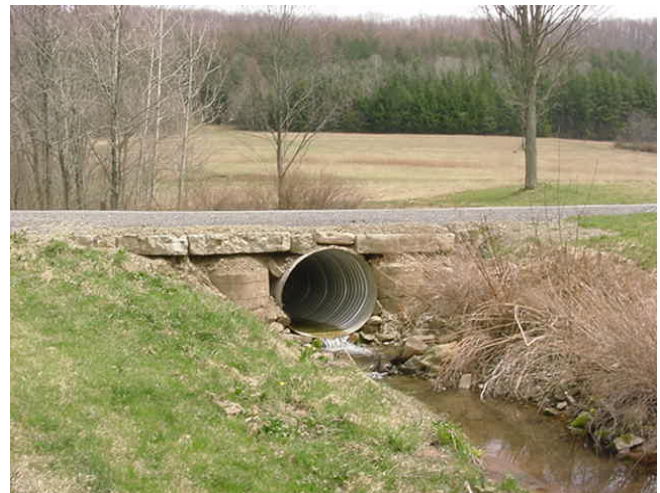
After: The pipe was re-sized and the road raised for proper cover over the new installation.

Adequate Culvert Size: A hydrologic & hydraulic analysis was used to determine the proper size of the culvert needed for the stream crossing. The existing 30" round concrete pipe was replaced by a 77"x 52" squash pipe. The road was raised to ensure proper cover over the new pipe.
