Worksite in Focus

Adams County Miltenberger Road

7/16/05

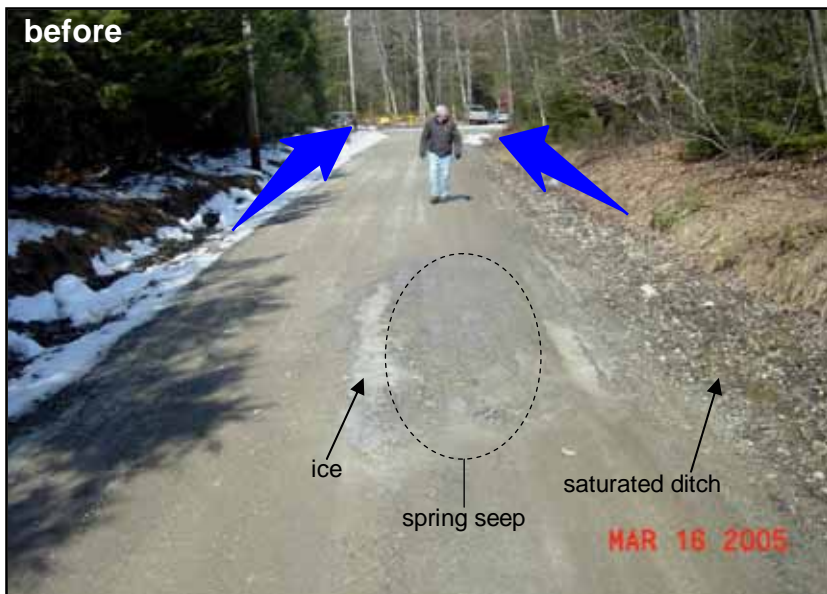
Photo 1. Notice the ice in the middle of the road from a spring seep. The entrenched road profile made it impossible to get water or snow off of the road.

Miltenberger Road was an entrenched road with few outlets for drainage and spring flow to leave the road area. Water was concentrated in parallel ditches and directed 1,200' downhill and under State Route 233 into Conococheague Creek. Water entering the road area had nowhere to go but down the ditches, gaining velocity and erosive force. Adding additional drainage outlets was impossible with the road at an elevation much lower than that of the surrounding landscape. The entrenched road profile also left little room to plow snow (*Photo 1*).

Although over 3,000 feet of Miltenberger Road was entrenched, cost limitations only allowed for enough shale to raise about 800 feet of the roadbed. Spring water entered the road profile as subsurface flow. This excess water saturated the road and ditches, softening the road base (*Photo 1*). The land surrounding the road is owned by the Bureau of Forestry.

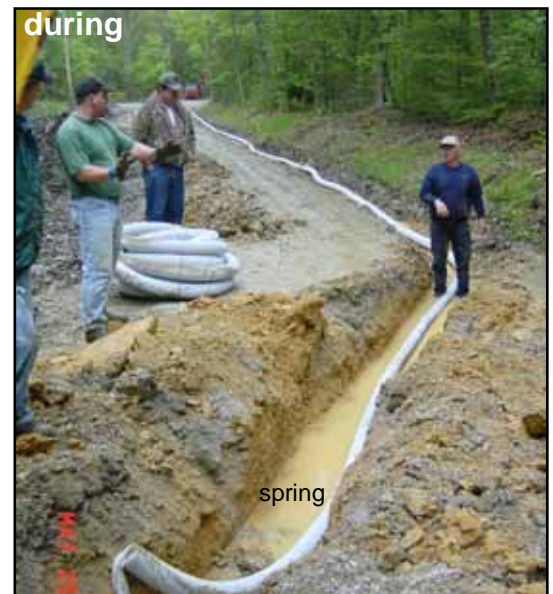
Photo 2. Pre-fabricated underdrain was used to collect subsurface water from under the road and both ditches.

Install underdrain: Pre-fabricated underdrain (4" perforate pipe wrapped in geotextile fabric) was placed under the road and ditches to collect subsurface water (*Photo 2*). The underdrain will keep clean subsurface water from mixing with road drainage. It will also reduce maintenance by allowing the road and ditches to dry.

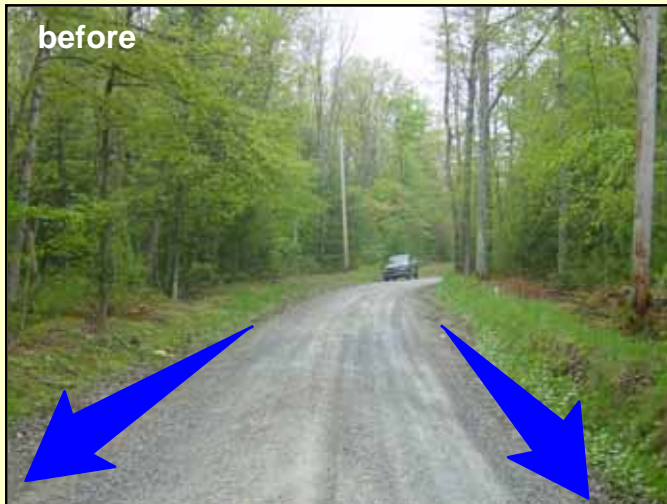
Photo 3. The entrenched road traps water in the road area and conveys it down to the stream. Note the elevation of the road relative to the utility pole on the right compared to *Photo 4*.

Raise the road elevation: Shale was purchased for use as road fill (*Photos 3 & 4*). The shale was spread with a bulldozer and compacted using a vibratory roller in approximately 8" lifts. The road was filled an average of 3' over an 800' length and tapered into the existing road grade on both ends. Filling the road completely eliminates one ditch, and provides the cover necessary to install crosspipes to outlet water from the remaining ditch (*Photo 5*).

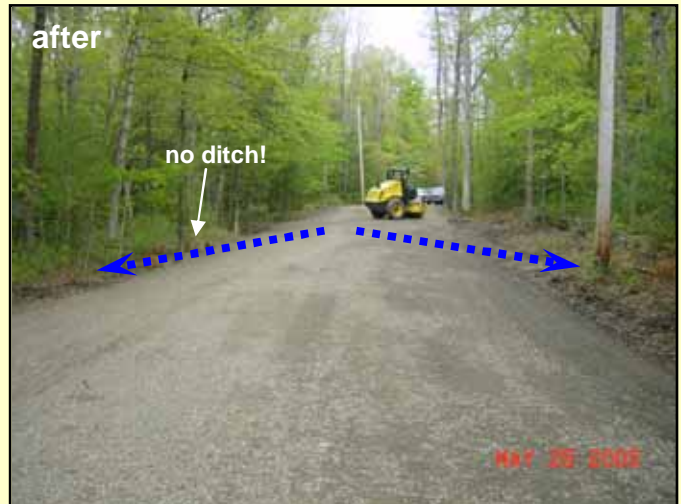
Photo 4. The road was elevated to eliminate the ditch on the left and achieve sheet flow. The added material also provided the necessary cover to install new crosspipes.

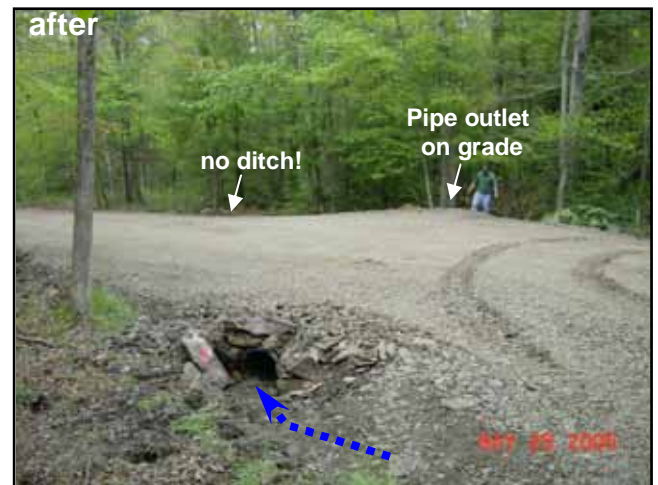
Photo 5. One of two new crosspipes installed. Notice the grade-break in the road over the pipe to get water off the road.

Install crosspipes: Because Miltenberger road was so severely entrenched, no crosspipes existed on the road before this project. Crosspipes were needed to divert drainage into vegetated areas and keep runoff from entering the stream. The new road elevation provided the extra cover needed for two shallow crosspipe installations. These crosspipes were outletted at the existing ground elevation to avoid creating an "outlet trench" into the woods. Gradebreaks were constructed over each crosspipe to obtain adequate pipe cover and divert water from running down the roadway (*photo 5*).
