Worksite in Focus

Warren County Hatch Run Access Lane

2/2006

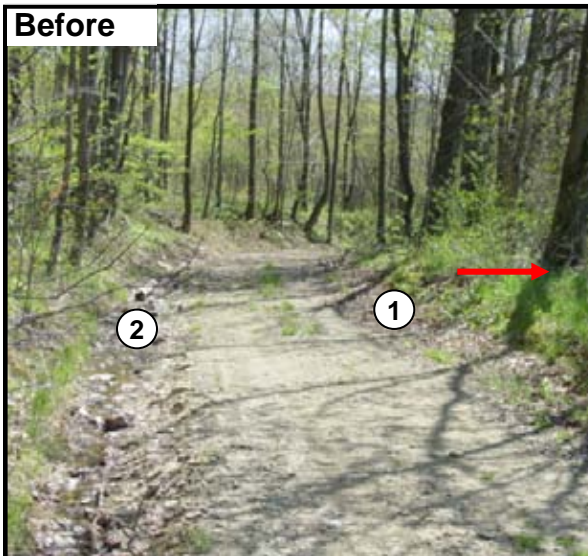
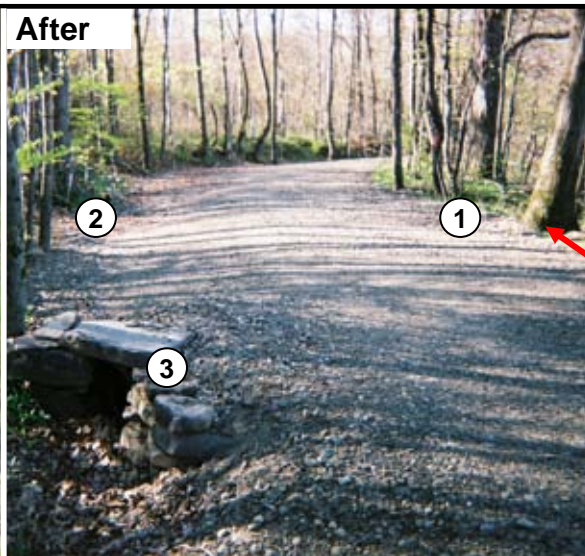
- 1 Road elevation was raised approx. 3'. Downslope ditch is eliminated. Note road elevation compared to red arrow on tree.
- 2 Underdrain installed in ditch to collect spring seeps
- 3 New crosspipe carries road drainage across road into woods.

Photo 1 & 2. This Before & After sequence illustrates many of the techniques used on the site. Before, road drainage continued in the ditch for almost 2000' where it emptied into a stream. After, this section does not affect the stream.

Raising the Road Profile: Approximately 3,100 tons of crushed bank run gravel were imported for use as road fill. Fill was placed in 8" – 10" lifts and compacted. Filling the road back to a natural elevation eliminated the need for a downslope ditch on much of the road, and provided the necessary cover to install additional crosspipes to outlet the upslope ditch. **(Photo 1 & 2)**

Underdrain: Approximately 800 feet of underdrain were installed along the access road to collect the many springs and seeps that brought water to the road ditch. **Photo 1** shows an example of the saturated road ditch that existed along much of the road before the project. Underdrain consisted of a 2' x 2' trench lined with geo-textile and filled with clean stone and a perforated 4" pipe. Underdrains were continued under the roadway where they could be outletted separately from crosspipes and road drainage. **(Photo 3)**

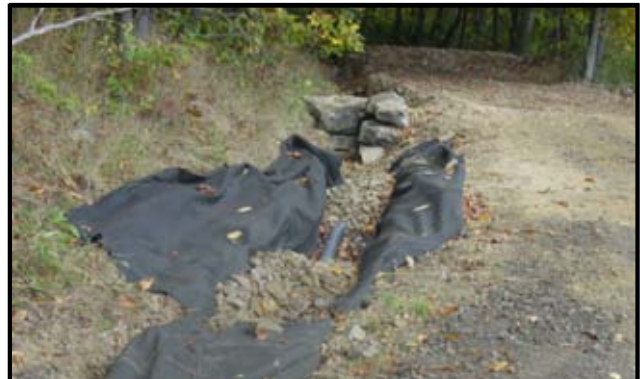
Photo 3: Underdrain installation in progress. Underdrain continues under road and outlets separately from crosspipe.

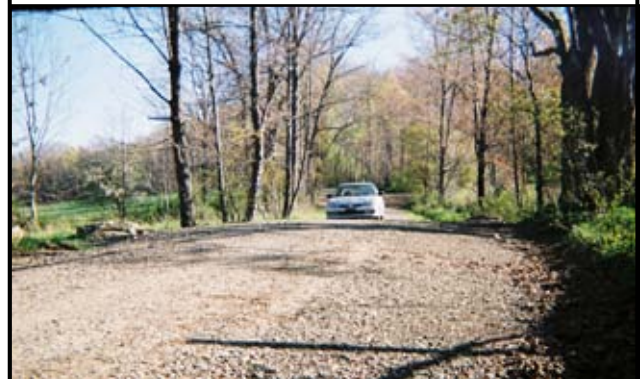
Photo 5: New Crosspipe installation with gradebreak. Top of gradebreak obscures car in bottom of gradebreak.

Surface Drainage Controls: Several gradebreaks were incorporated into the road surface as part of raising the road elevation. These gradebreaks are simply elongated "speed humps" in the road surface that prevent water from flowing down the roadway and force it into roadside ditches. They are typically used over crosspipes to supply additional pipe cover and force water off of the road and into the pipe.
