Worksite In Focus

Carbon County Mauch Chunk Lake

Project Overview:

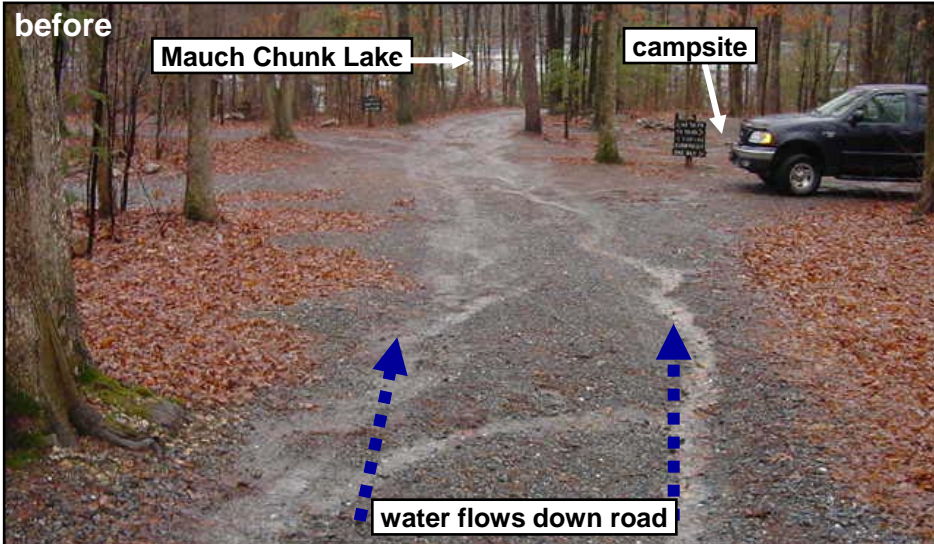
Photo 1. A typical section of the campground loop road is shown here. Few water control structures means that water runs down the road, through campsites, and into the lake.

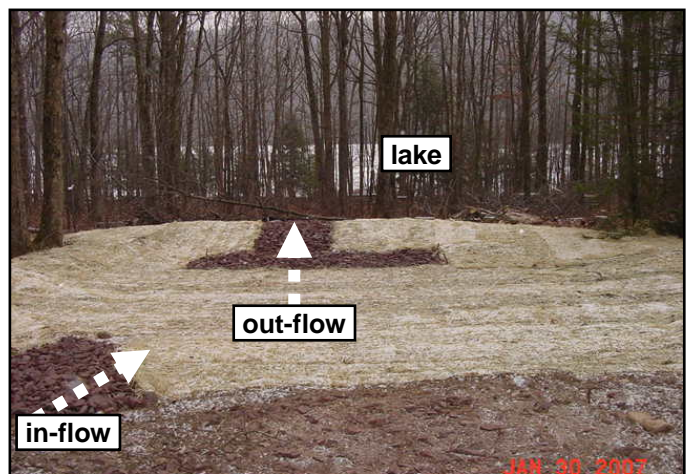
Photo 3 illustrates a “level-spreader” designed to slow runoff and encourage infiltration. Water from a road ditch enters from the bottom left of the picture. Water is retained in the structure until it infiltrates or percolates through the “French mattress style” outlet. The bottom edge is built wide and level to spread water from high flow events over a larger area instead of concentrating it in a ditch. Before this structure, the eroded road ditch cut a channel away from the road, through the woods, and into the lake.

Photo 3. Level spreader to control and slow runoff.

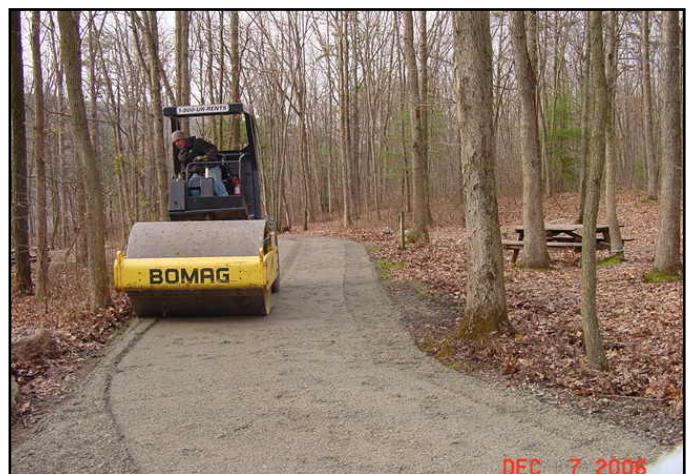
Once all of the drainage issues were addressed, Driving Surface Aggregate was placed using a motor paver and compacted with a roller. Placement widths varied as the camp road wound through the trees between campsites. Edge compaction of the DSA was critical in this case to insure that campers could easily pull low-clearance vehicles into campsites without “bottoming-out” on the aggregate edge.

Photo 5. Compaction of paver-placed Driving Surface Aggregate
