Worksite in Focus

Red Rose Revisited 2001 – 2009: eight years later

Project Overview:

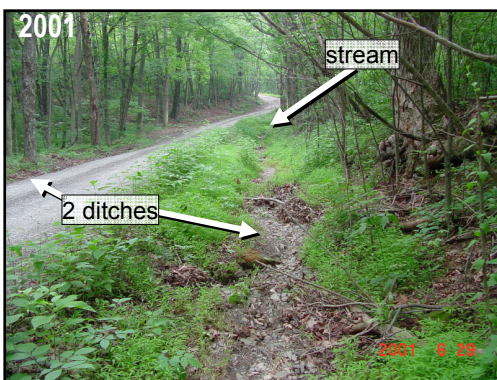
BEFORE. Entrenched road traps runoff in ditch, transporting it to stream. Heavy canopy and insufficient cover to install crosspipes.

The best permanent solution for Red Rose Road was to restore a more natural drainage pattern by raising the road elevation. An on-site shale pit was used to raise over 1,000 linear feet of road 3 to 6 feet in elevation in compacted 8” lifts. (See photo sequence on reverse) Raising the road eliminated the downslope ditch, and provided necessary cover for crosspipes to be installed to drain the upslope ditch.

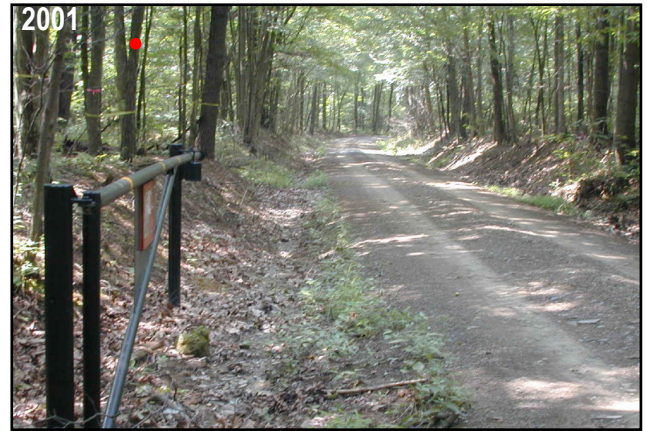
BEFORE. Existing entrenched roadway traps drainage and transports it to stream around bend.

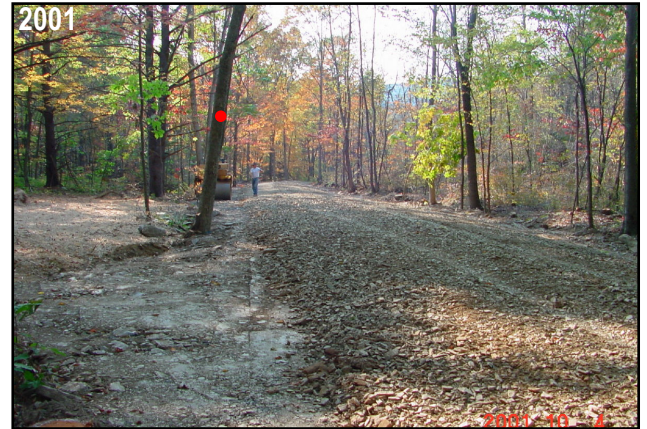
DURING. Entrenched road is filled with shale. Trees are selectively thinned.

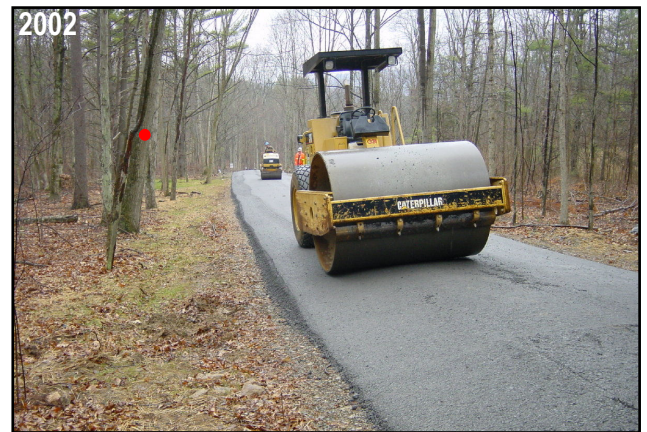
DURING. Driving Surface Aggregate is placed 8" deep using a motor-paver and compacted to 6" with a roller.

DSA: ~\$10,000
6” compacted depth, paver placed, roller compacted

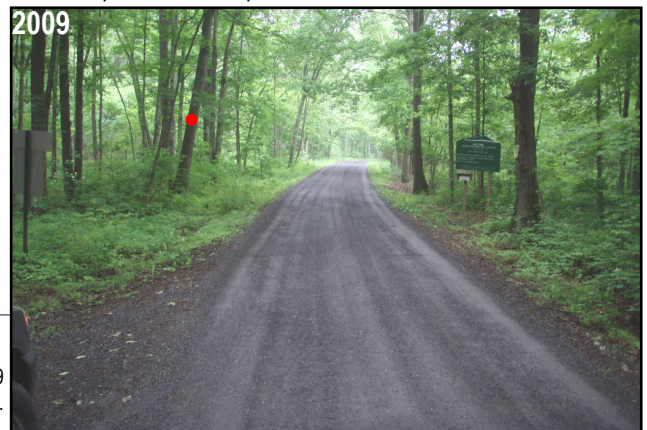
AFTER. Raising the road provided a long-term solution to the runoff issues on Red Rose Road.
