Worksite in Focus

Linn Run Road Somerset / Westmoreland County

7/2008

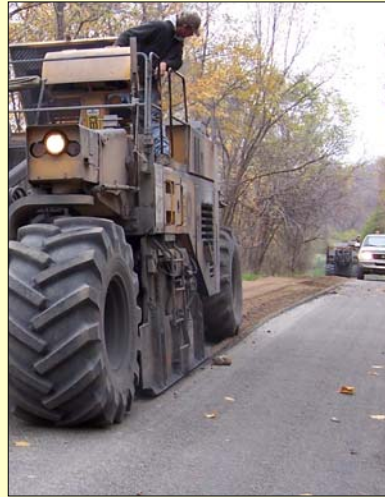
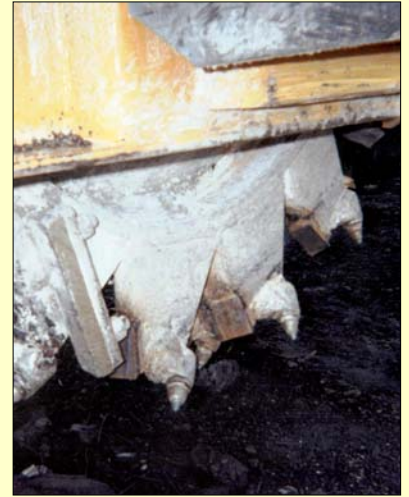
A full depth reclamation, which was planned for the road, involves the use of a Road Reclaimer, pictured to the right, which grinds asphalt into usable aggregate using a spinning drum with carbide-tipped teeth, pictured to the far right. In this process, the Road Reclaimer is used to grind up the asphalt, and to mix in any additional material or stabilizers. Material may be added to the road in order to achieve the most durable road aggregate. The type and amount of additional material is determined by examining core samples of the road. The final shape of the road is then achieved using a motor-grader.

*These two photos are NOT from Linn Run Road. Photos courtesy: Cutting Edge Reclamation, LLC
